Servo Service Bulletin #060810

Date: June 8, 2010

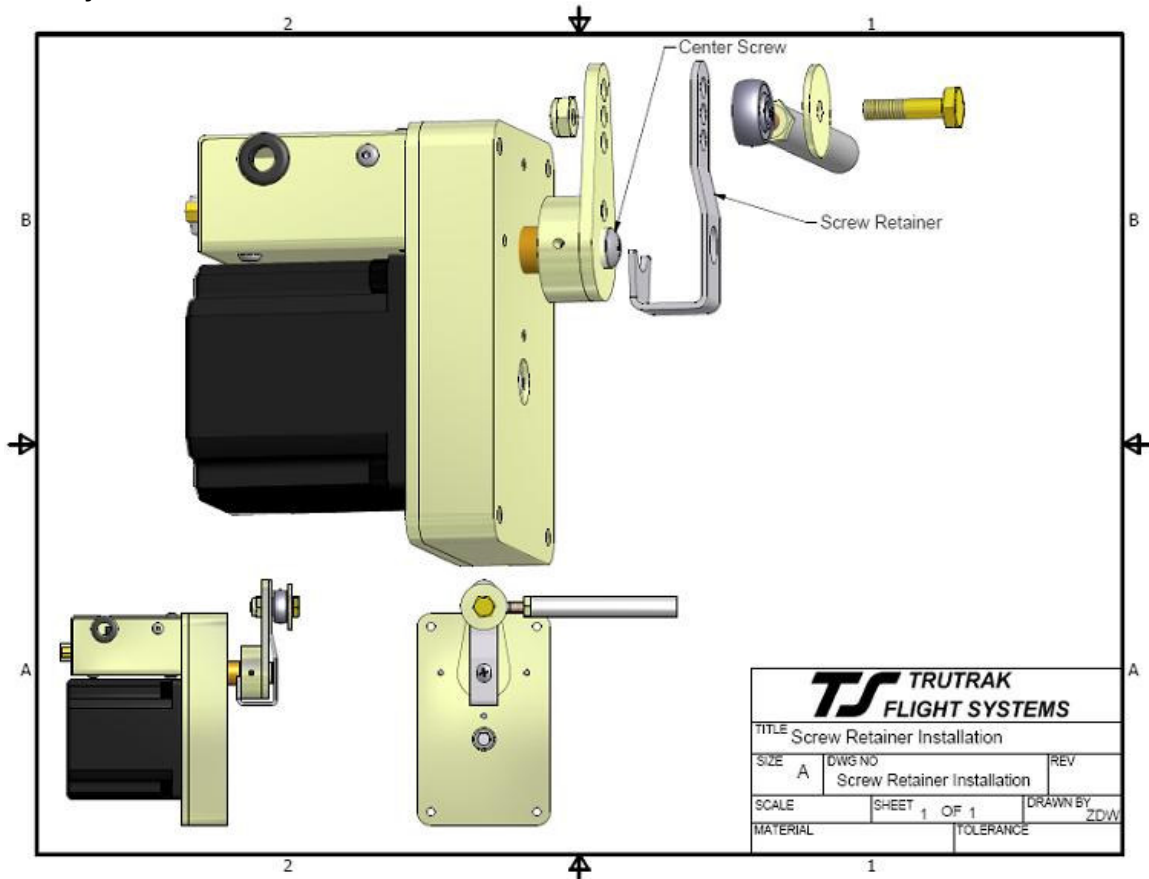
Recent reports have suggested that there could be a problem with the new integrated thread-locker servo arm screws that have been sent out for retrofit by customers in the field. Reports indicate that the screw could back out of its hole in the end of the servo shaft during normal usage. In speaking with the manufacturer of the new servo arm screws, the suspected cause is residual chemical thread-locker in the threads of the servo shaft which was the previous method for locking the arm screws in place. While there are only a very few reports of this actually happening, Trutrak Flight Systems wants to take steps against the possibility of this happening. We will include the bracket shown below with all new servos shipped with the current servo arm screw. This bracket will also be available to all customers with the current servo arm screw configuration as a field retrofit solution.

Below is a drawing of the proper installation of the screw retainer. Trutrak Flight Systems has decided to alter the arm attachment method in future servo production. The shaft will have a threaded portion protruding out with an elastic stop-nut used to attach the arm to the servo shaft. The stop-nut requires much more removal torque than the currently used screw method. This will ensure that arm will not become loose during normal operation.
