*Repair of fuel tanks  
Pulsar 912 XP  
OY-LLE*

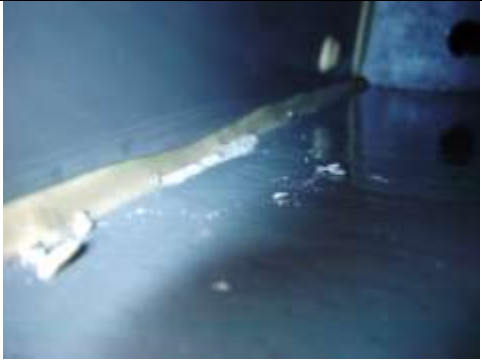
<p>Upon removal of close out panels it became clear that the sealant was not at all a sealant, but an unprotected fillet of epoxy mixed with micro balloons. According to AeroDesign construction manual these fillets should have been covered with 2 layers of glass tape, before a protective cover of Jeffco 9700 was added.</p> <p>Unfortunately AeroDesigns – who had manufactured and partly assembled wings – had not followed their own building manual. The part was never questioned as the part was delivered in a finished state from AeroDesigns.</p> <p>The Micro fillet had become elastic / rubber like as a result of exposure to fuel (Believed to be due to auto fuel, whereas resistant to Avgas)</p> <p>All micro fillets were attacked, although right tank seemed to be in worse condition.</p> <p>All fillets had to be replaced, missing glass tape and a protective cover of fuel tank sealant to be added.</p>

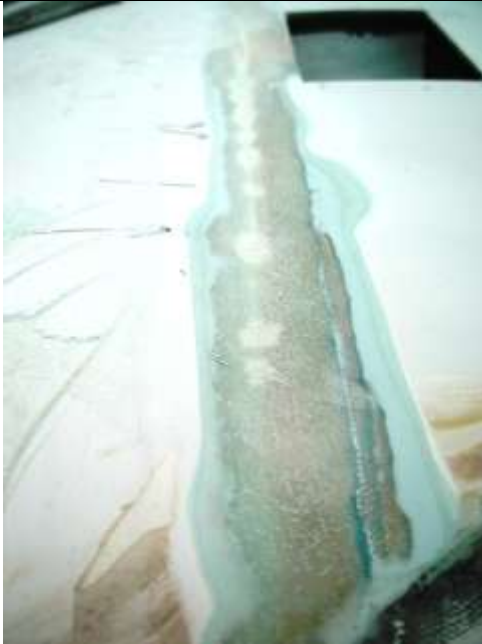
3

<p>Paint, filler and glass reinforcement (AD note) was sanded down following the joint on the main spar. A number of failures were found under the right hand tank.</p>

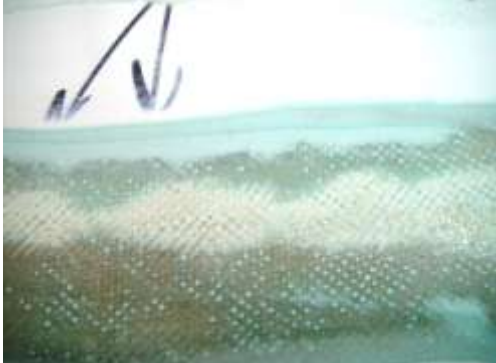
4

As picture 3, but close up. Attacked areas are clearly visible.
5

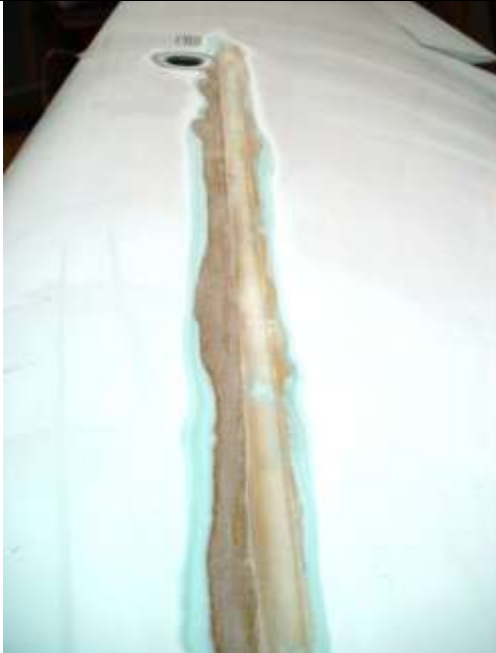
Top of wing was sanded down following the spar joint, but no failures were found.
6

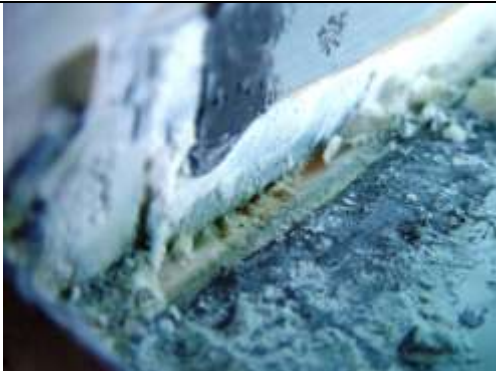
Close up of interface spar and fuel tank flange with micro partly removed. Note how fuel has penetrated micro down into, and damaged the joint. The micro held fuel which could be smelled when working the micro...but not in liquid phase.

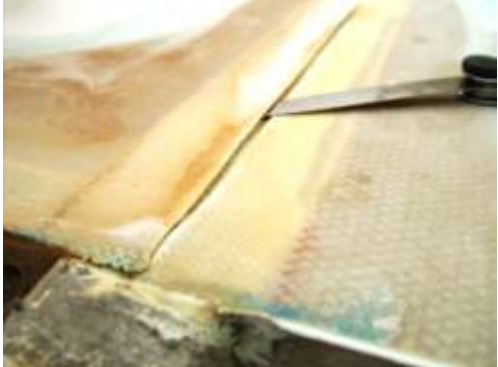
7

<p>The bond main spar to fuel tank flange was non existing, and a feeler gauge passed easily through the slot. This is true for both tanks, but only over a distance of app 300mm from tank close out and outboard. Rest of the flange length the adhesion was OK. The main spar and wing skin / epoxy was checked and found unaffected.</p>
8

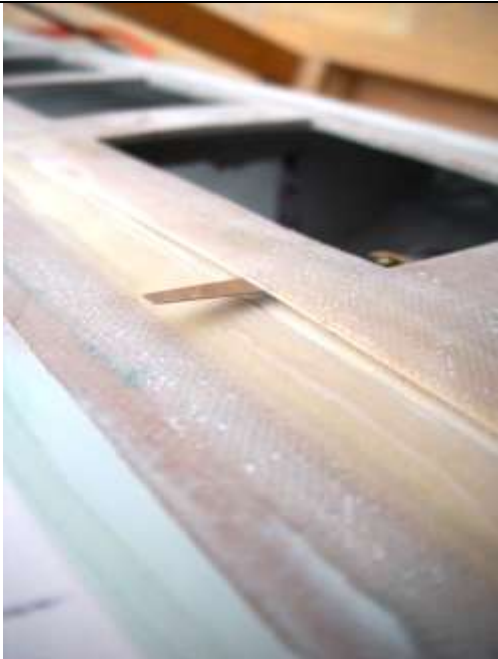
<p>As picture 7 but right hand wing.</p>
9

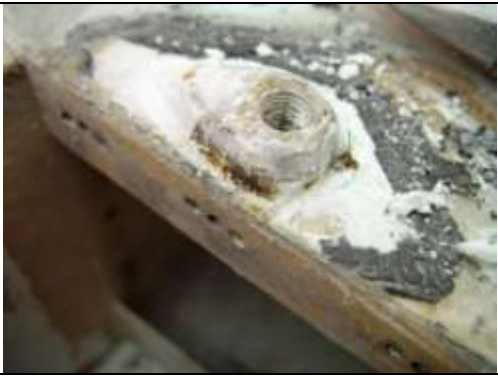
<p>Even reinforcement for drain valves – that are bonded on to the wing skin had been attacked due to a surface of a few tenths of a millimetre exposed to fuel. Note miscolouring of micro / epoxy.</p>
