*Repair of fuel tanks
Pulsar 912 XP
OY-LLE*

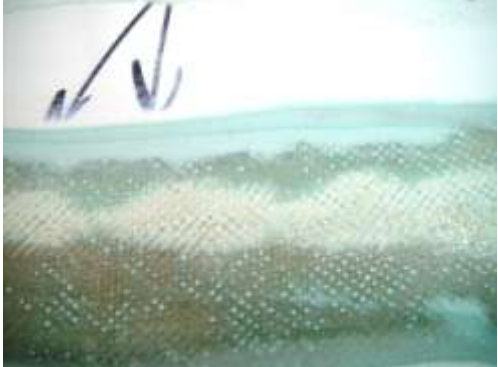
4

As picture 3, but close up. Attacked areas are clearly visible.
5

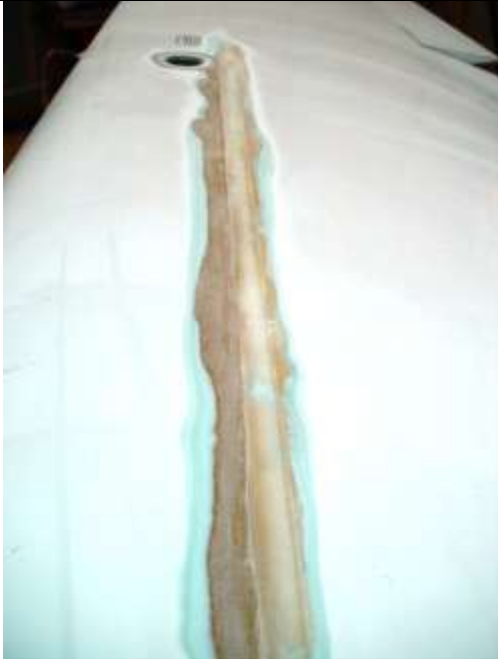
Top of wing was sanded down following the spar joint, but no failures were found.
6

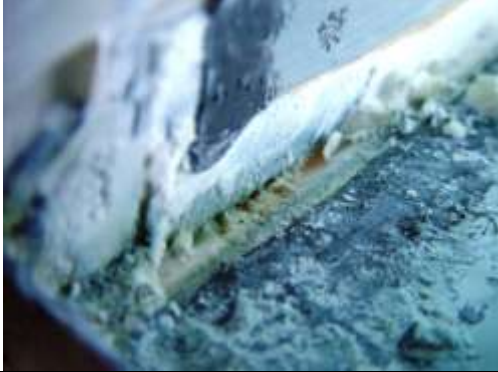
Close up of interface spar and fuel tank flange with micro partly removed. Note how fuel has penetrated micro down into, and damaged the joint. The micro held fuel which could be smelled when working the micro...but not in liquid phase.

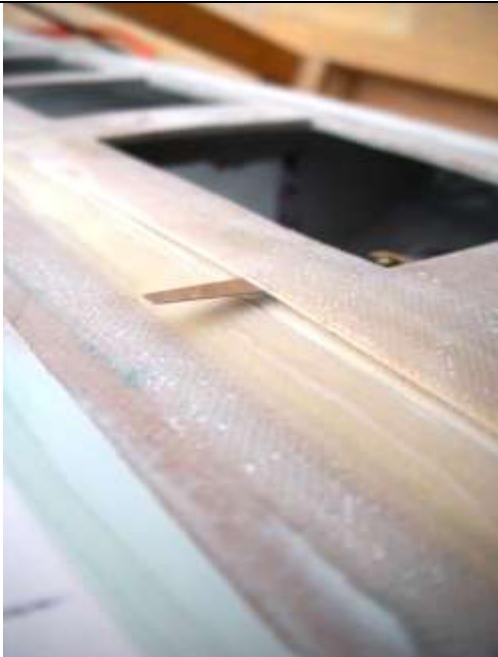
<p>As picture 7 but right hand wing.</p>
9
