**VAN'S AIRCRAFT**  
TOTAL PERFORMANCE

## SERVICE BULLETIN 00134 REV 1

**Subject:** Horizontal Stabilizer Forward Attach Bolt Position

**Affected Models:** RV-4, RV-6/6A, RV-7/7A, RV-8/8A

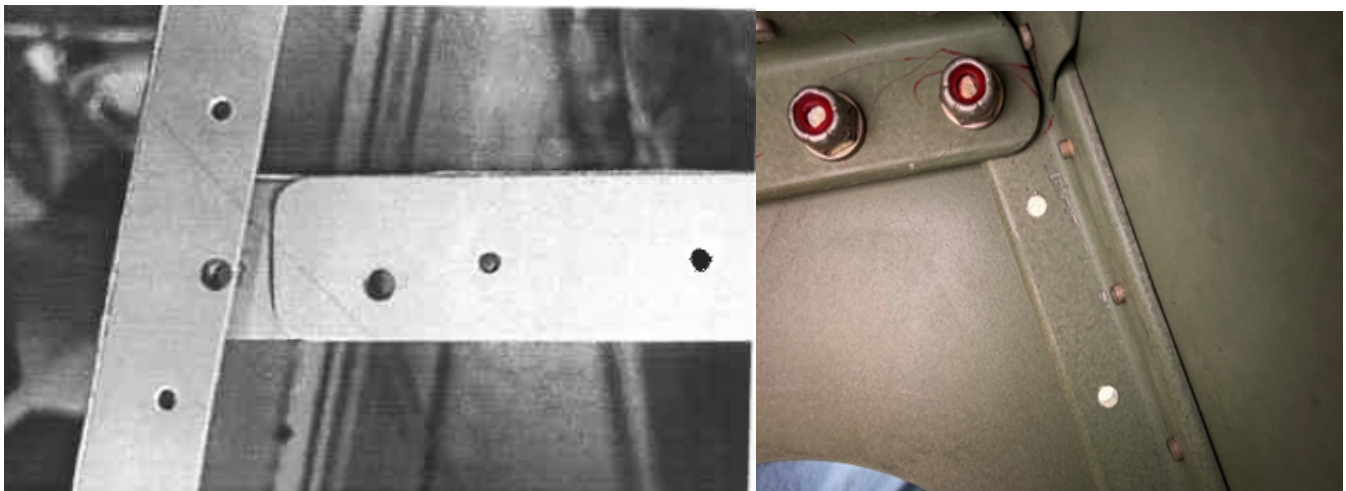
The strength of this joint and the airframe structure as a whole is relatively tolerant of variations in the outermost bolt hole position in the fuselage longerons, even where this involves less than what are normally considered minimum edge distances, zero edge distance and even bolt holes cutting through the inner edge of the longeron flange.

In the fuselage longeron, spanwise locations of the outermost bolt positions that result in the hole for the outboard bolt having a reduced edge margin in the longeron, cutting through the inboard edge of the longeron or missing the longeron altogether is acceptable. See Figure 1.

**FIGURE 1:** LONGERON REDUCED EDGE DISTANCE  
(HORIZONTAL AND TOP DECK REMOVED)

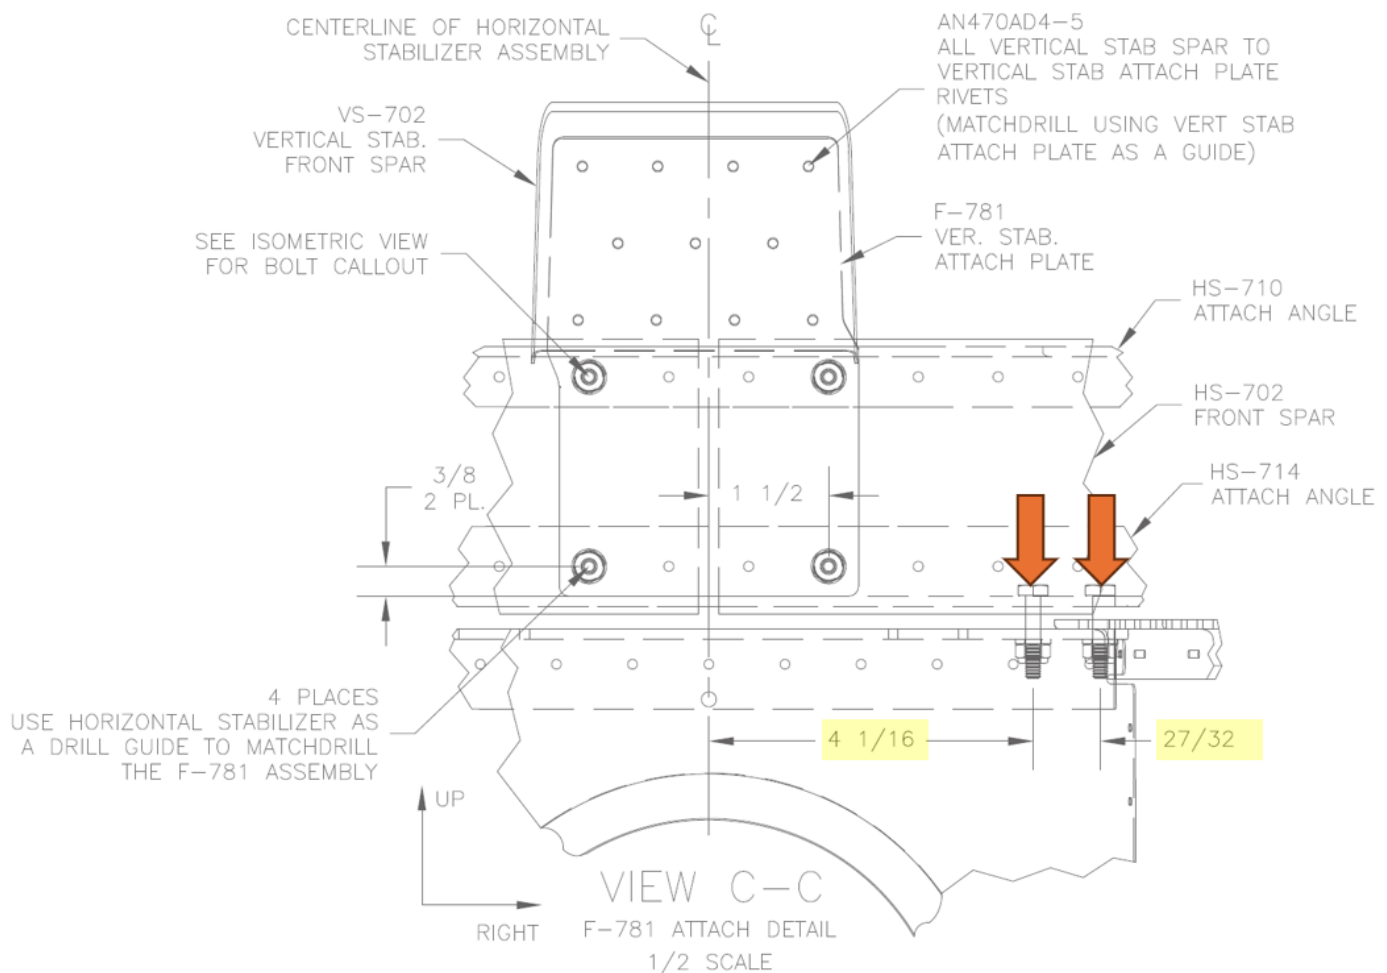
**FIGURE 2:** RV-7 DEG 27A TYPICAL HORIZONTAL STABILIZER ATTACH FRONT VIEW

Step 2: Measure the distance between the attach bolts on one side of the aircraft (see the set of bolts marked with arrows in Figure 2 with a distance of 27/32 inches between them). At minimum the distance between the bolts should be 25/32 inches. If the distance is less than 25/32 inches contact Van's Aircraft for further assistance.

Step 3: Measure the edge distance between the center of each bolt hole and the forward edge of the HS-714 Attach Angle. Repeat the measurement for the forward edge of the F-710B Angle. See Figure 2 and Figure 3. In no case may the edge distance be less than  $e/D = 1.5$  ( $e/D$  the distance from the center of a hole to the edge of the part divided by the diameter of the hole  $.1875 \times 1.5 = .281$ ). If the  $e/D$  is less than 1.5 contact Van's Aircraft for further assistance.

For example, Figure 2 the center of the bolt pattern would be 4 1/16 inches plus half the distance between the bolts or half of 27/32 inches which results in a bolt pattern center distance to the centerline of 4.484 inches.

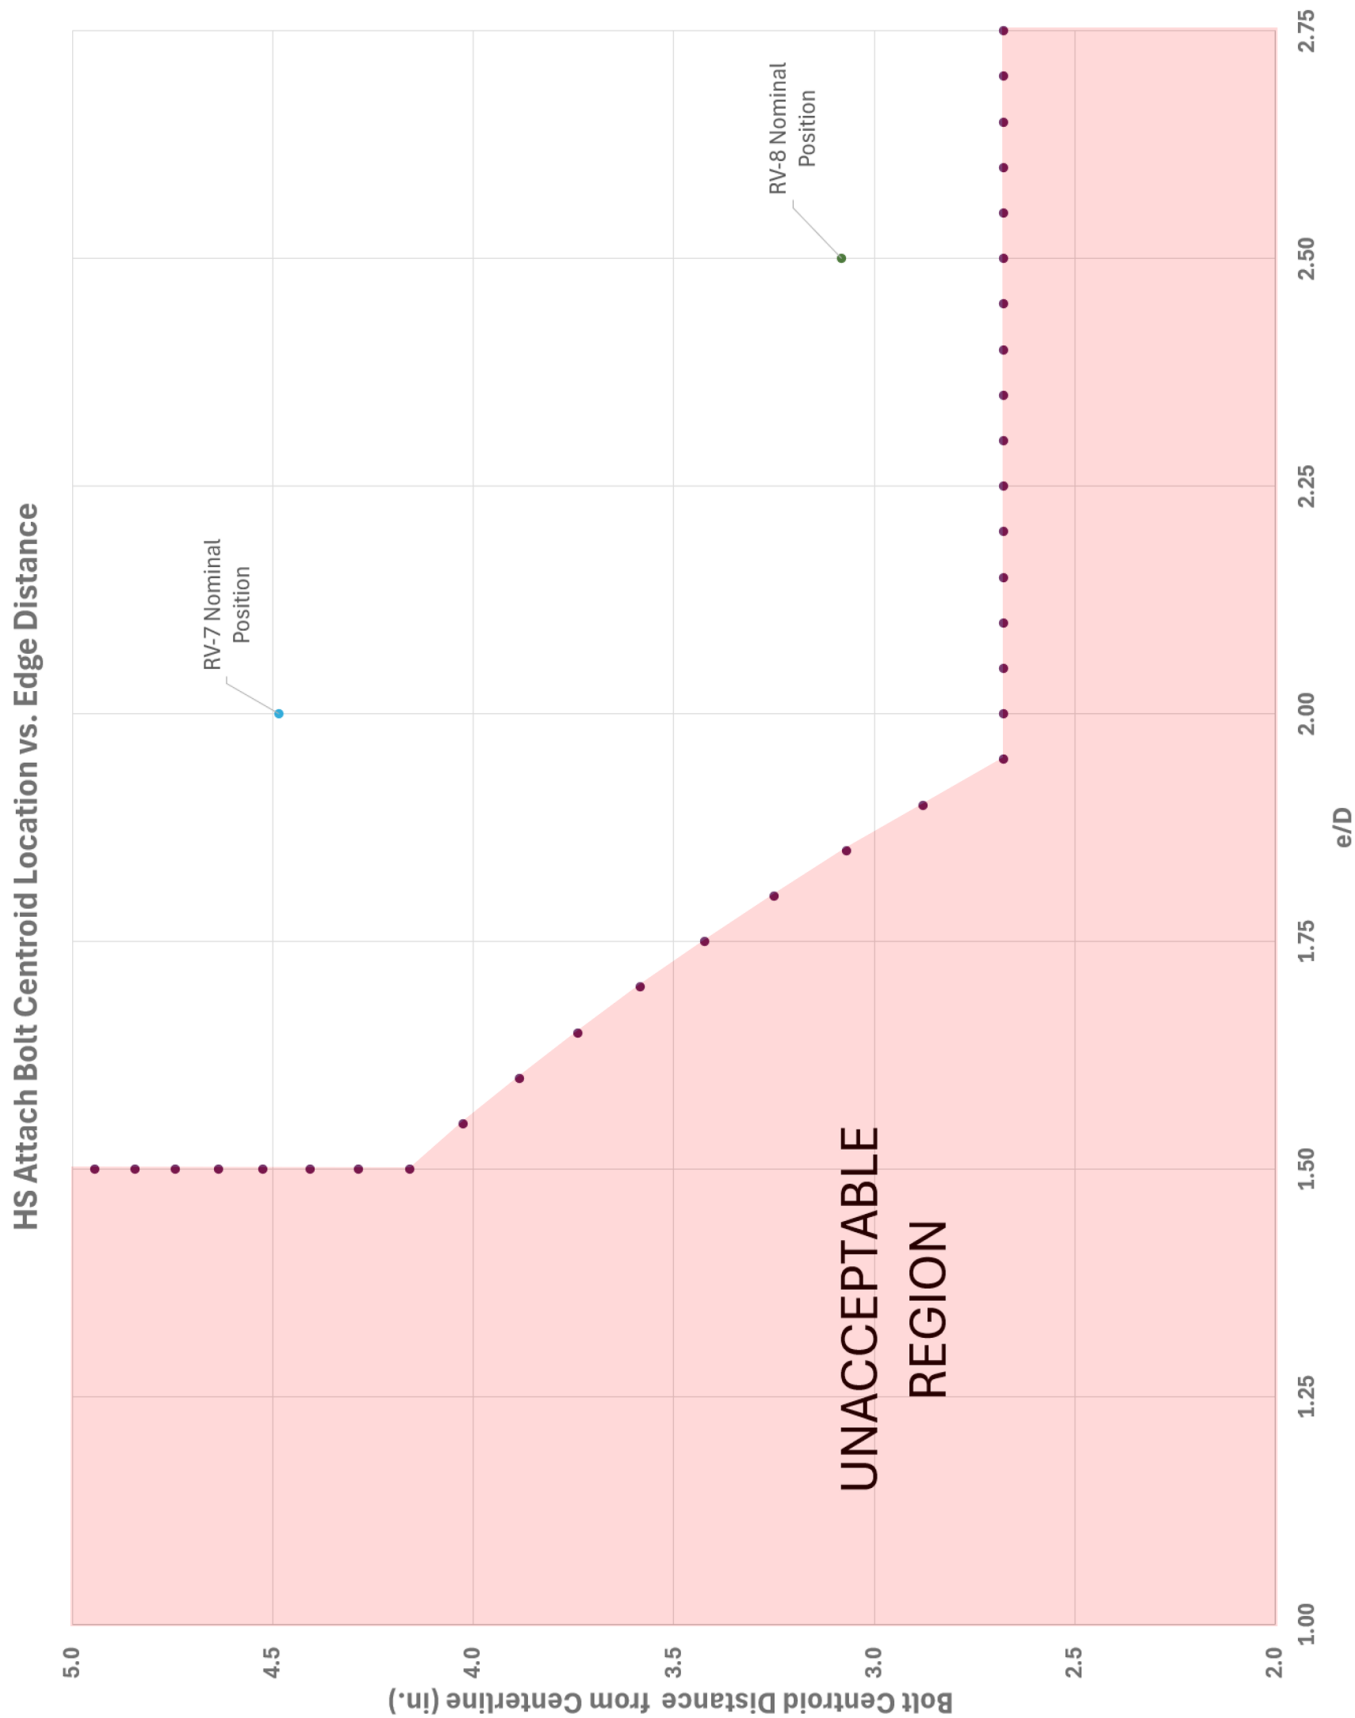
**FIGURE 4: ACCEPTABLE BOLT POSITION CHART**

For the edge distance between the center of the bolt position and the forward edge of the F-710B Angle and HS-714 Attach Angle, the minimum acceptable  $e/D$  may be more than 1.5 depending on the results obtained in Step 5 and the values in the chart in Figure 4.

Step 5: Plot the  $e/D$  value between the hole center and the forward edge of the attach angles from Step 3 and the bolt pattern center distance to the centerline measured in Step 4. The plotted point must be outside the unacceptable region noted in Figure 4.

For example, the bolt pattern distance from Step 4 was 4.484 inches. Assume the nominal  $e/D$  of 2. This example corresponds to the RV-7 nominal point given on the chart in Figure 4. If the point on the chart is within the unacceptable area on the chart contact Van's Aircraft for further assistance.

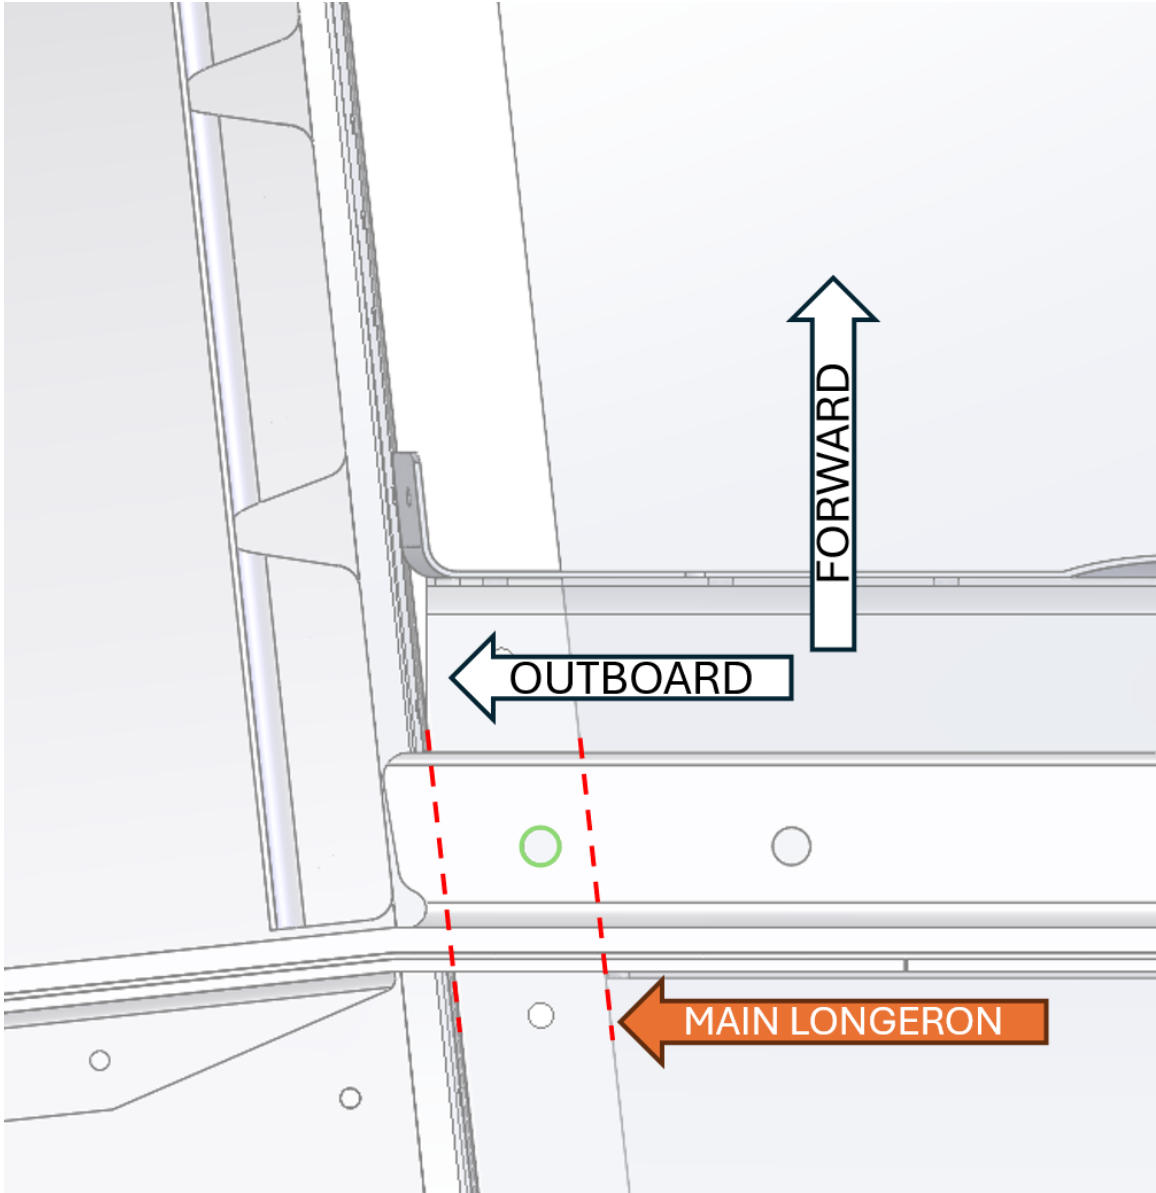
**FIGURE 5:** OUTBOARD BOLT POSITION & e/D

Measure the edge distance between the center of the outboard most bolt holes and the outboard edge of the HS-714 Attach Angle. In no case may the edge distance be less than  $e/D = 1.5$ . If the  $e/D$  is less than 1.5 contact Van's Aircraft for further assistance.

Check to ensure that the outboard end of F-710B is resting on the F-718 Longerons. Measure the edge distance between the center of the outboard most bolt holes and the outboard edge of the F-710B Angle. In no case may the edge distance be less than  $e/D = 1.33$  ( $.1875 \times 1.33 = .249$ ) unless the entire diameter of the outboard most bolt hole is within boundary of the main longeron (see Figure 5) in which case the edge distance of  $e/D = 1.00$  ( $.1875 \times 1.00 = .188$ ) is acceptable. If the  $e/D$  is less than those specified above contact Van's Aircraft for further assistance.
