RV Flap Motor Info

RV Flap Motor Brush Replacement Info

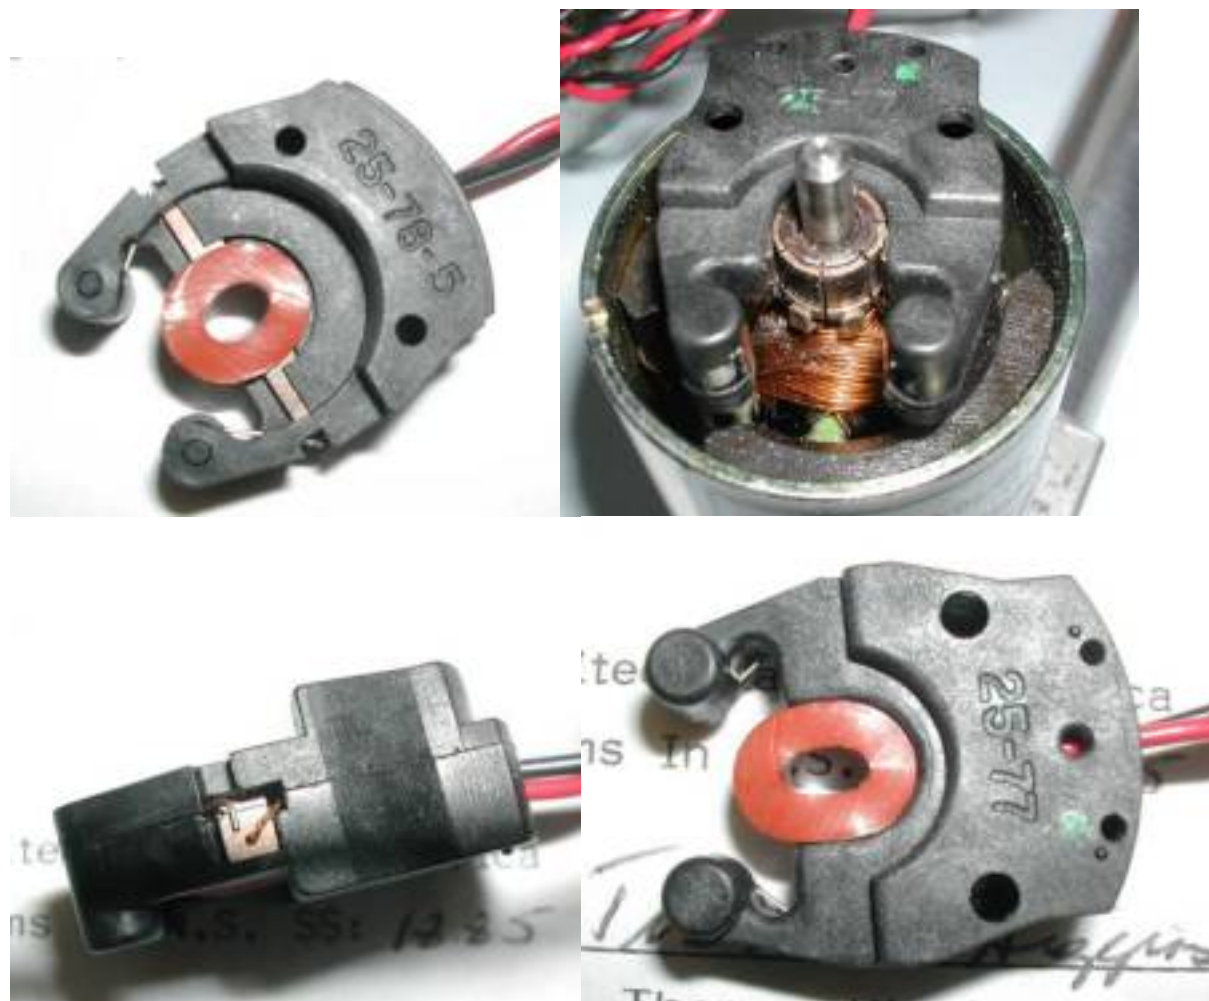
I'm sending this off line; photos don't get posted on the RV squadron. This shows the side of the

brush assembly that faces the body of the motor. You can see the plastic bung to prevent the brushes from springing out. You have to ease this out while fitting the assembly to the commutator. I pushed at the bung with one finger to hold the brush on one side, and held a thin knife against the other brush as I pushed the assembly onto the commutator.

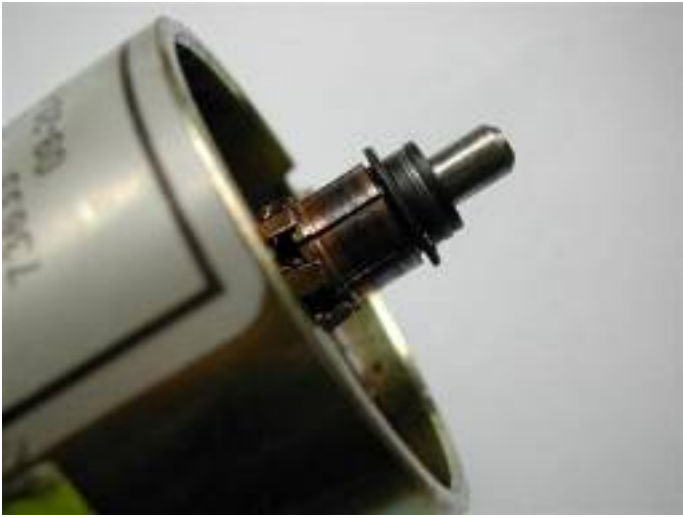
This is the opposite side showing the small central hole into which the pip on the motor cap fits. This shows the outside edge of the brush and part of the spring. Here you can see the sequence of washers I mentioned previously.

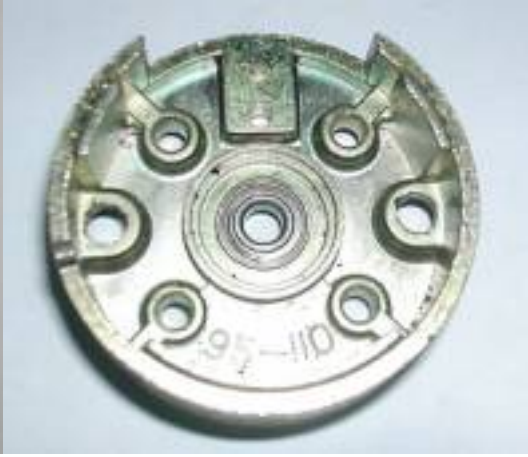
Here is the brush assembly in place. All that dust is carbon. It was not at all obvious to the naked eye, but the camera picked it up. Needless to say I cleaned it up with cotton buds. Inside of the motor cap, the small pip at the top engages with the hole in the brush assembly. The notch on the left engages with a slot in the motor casing. Be careful on re-assembly to ensure that these pips are engaged and don't tighten up screws until they are. I hope this is helpful.
