BEEFING UP THE BELLCRANK BRACE

Hello again from Bill's Airplane Building Shop. Remember, we are the folks that recently brought you the aileron push rods saga in 601XL. If you recall I had a wonderful disclaimer and a warning not to do what I did.

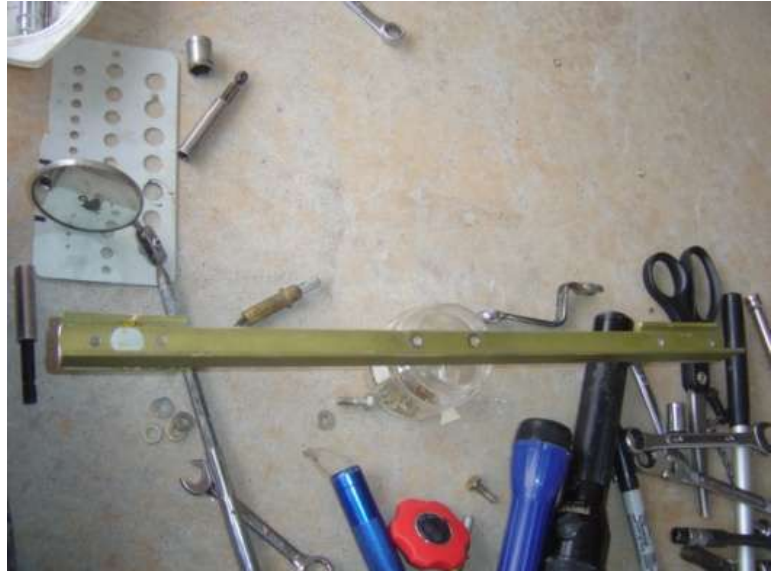
I made some spacers under the brace the same thickness and the hinge bottom so it would lay flat to the rib. Seen here at the ends.

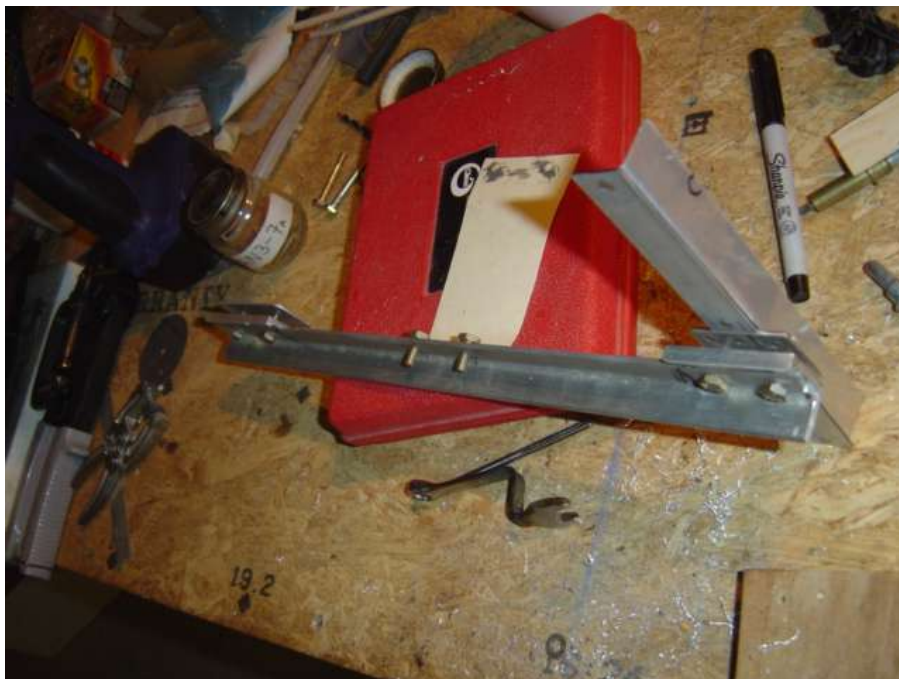
Further, I added a .025 "L" angle behind the center span to spread the load to even more rivets. This one is for the right hand wing. Custom made with flush rivets and countersinking

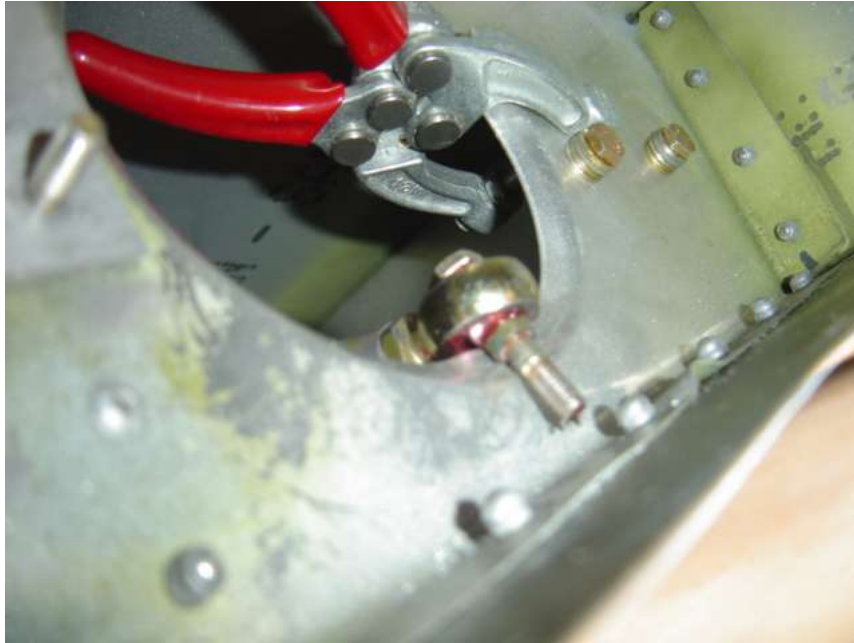
I had to make spacers under the brace to level the cross brace with the height of the hinge.

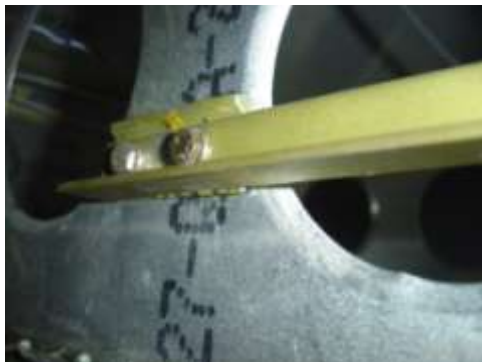
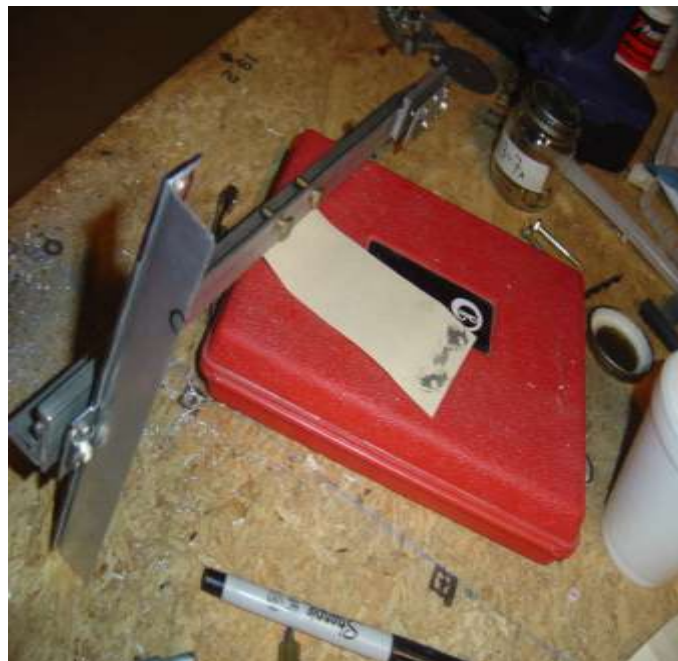
Also, because there was just no way to get and hold nuts on the back side of the rib I made a plate with nut plates that I glued in place with yellow adhesive. Here you see where I clamped and glued the nutplate plate to the inboard side of the rib spans.

I used pull rivets on the orward span "L" ange I added. I intergarted it with the nutp late plate.

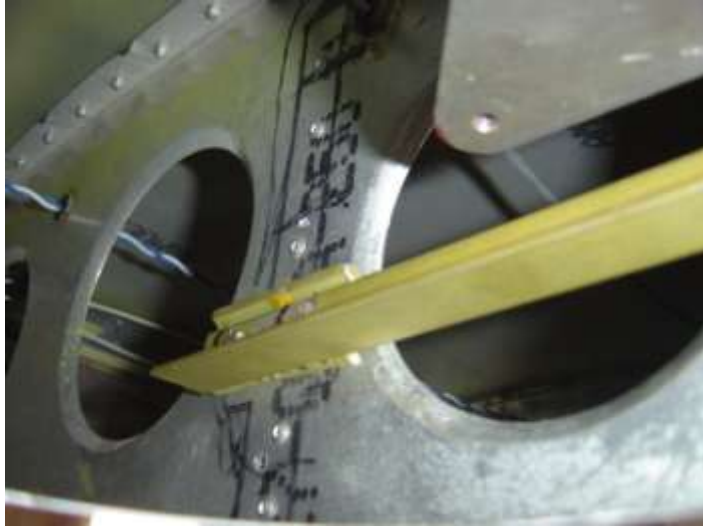
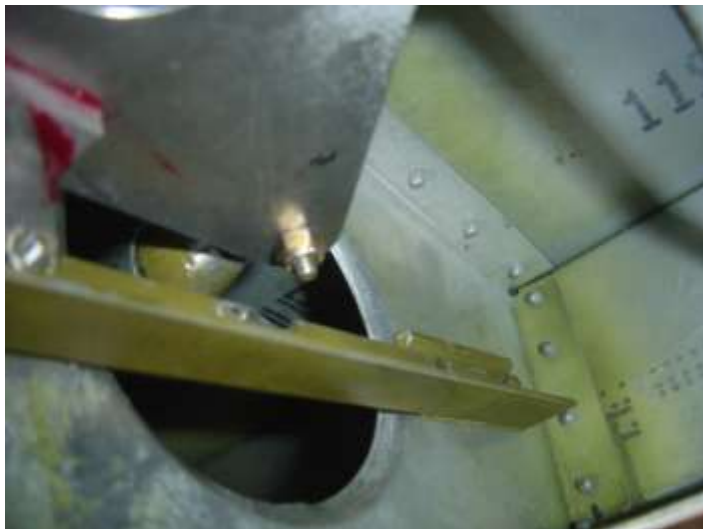
These three photos are my attempt to show the brace in place. This is on the left wing from front to rear in 3 exposures.
