Group Test of Fire Retardant Sealers

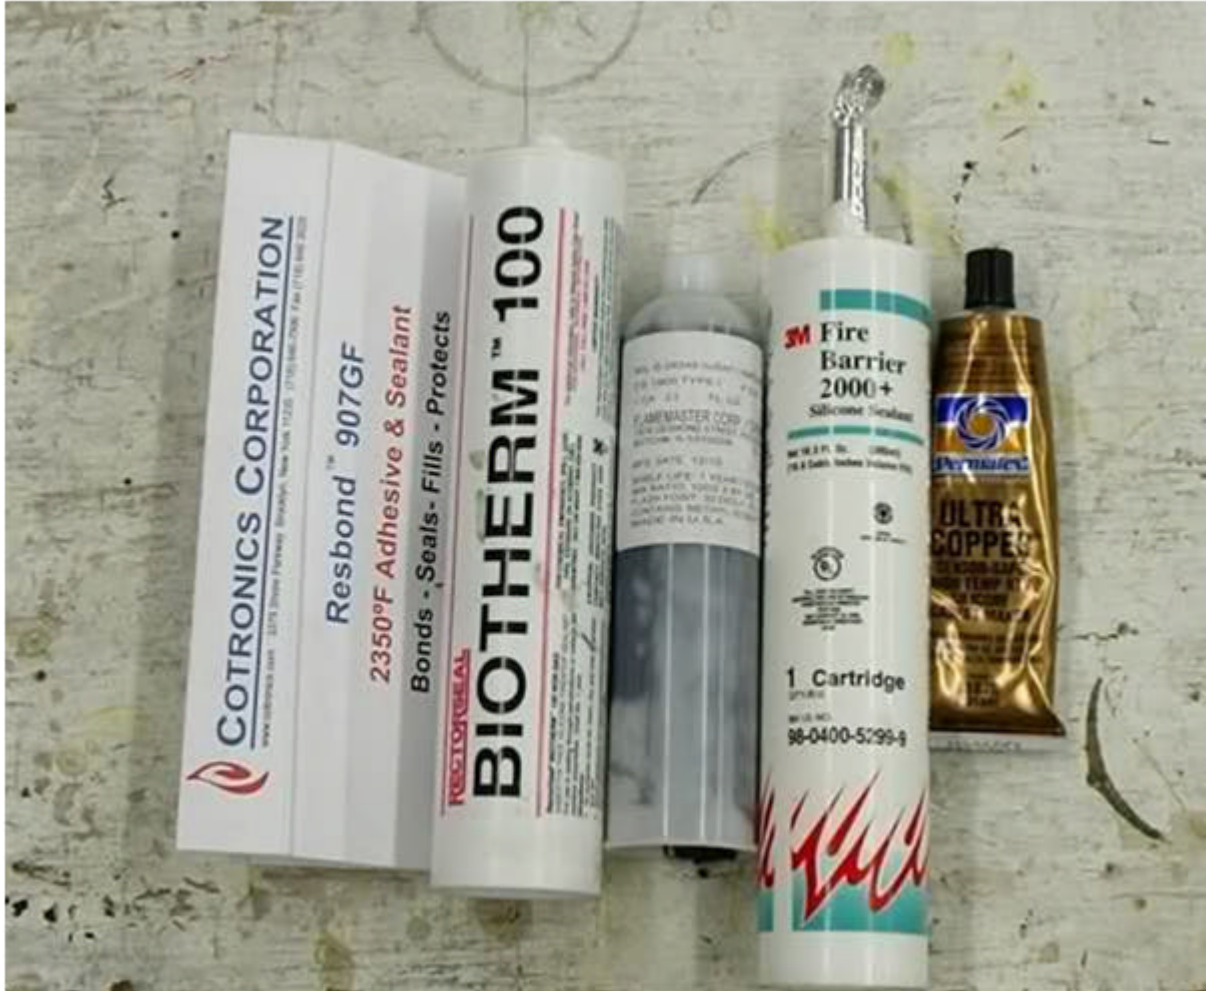
First, the candidates:

Cotronics Resbond 907GF (courtesy of Don Pansier)

Rectorseal Biotherm 100 (courtesy Dan Langhout)

Flamemaster CS1900 (courtesy Dan Langhout)

3M FireBarrier 2000

Permatex Ultra Copper

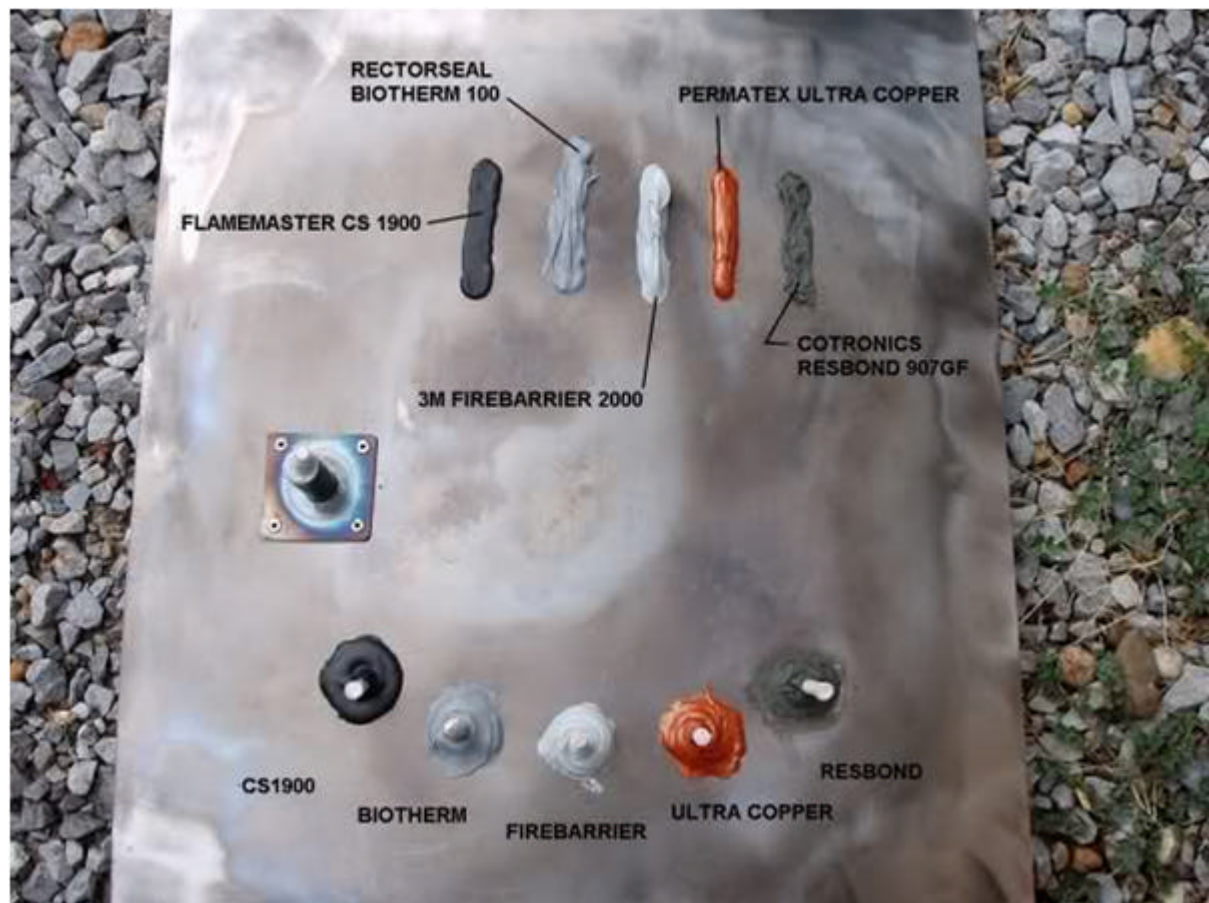
The setup:

18 x 24 sheet of stainless firewall material. At the top are simple strips of sealant on the front and back of the panel (staggered). At the bottom we have actual firewall electrical penetrations, very basic; 6-gauge tefzel wire through plastic snap bushings, then covered with sealant, without SS shields. I selected this sort of pass-through because they are commonly seen on experimental aircraft. On the left is a personal experiment, the pass-through style on my own airplane, a 2"x2" .032 plate with a 1.5" long .035 tube, welded 4130. The cable, wires, or whatever is inserted, then the tube is pumped full of sealant.

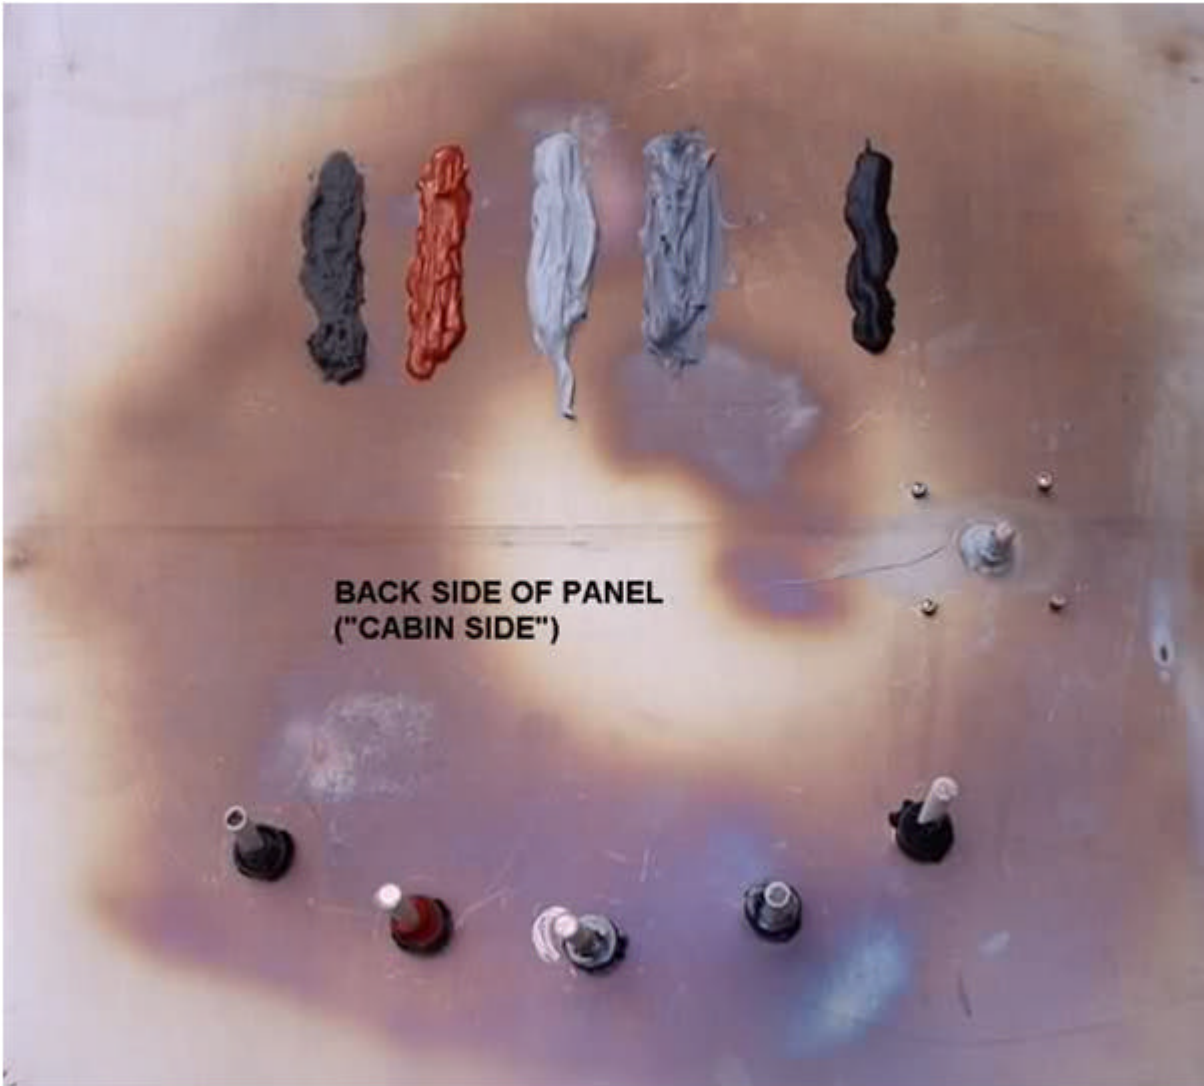
Here's the back of the panel. I made a point of equally filling each snap bushing with sealant

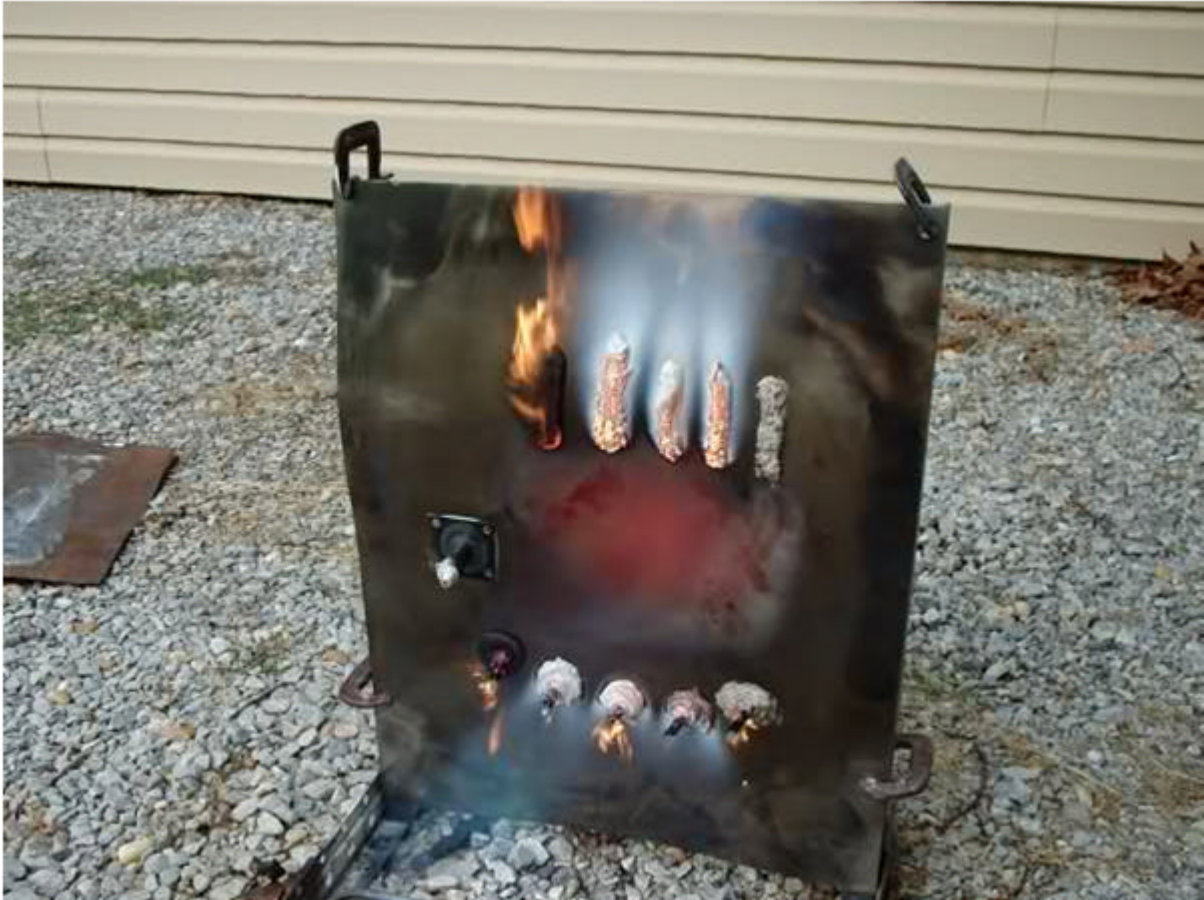
Bring on the heat.

First the burn rig was calibrated to approx 2000F using copper sheet. Note that (compared to previous firewall tests) I have reworked the torch nozzle to obtain a tighter, more horizontal hot spot pattern. Also note that none of the sealant samples here are actually in the 2000F hot spot.

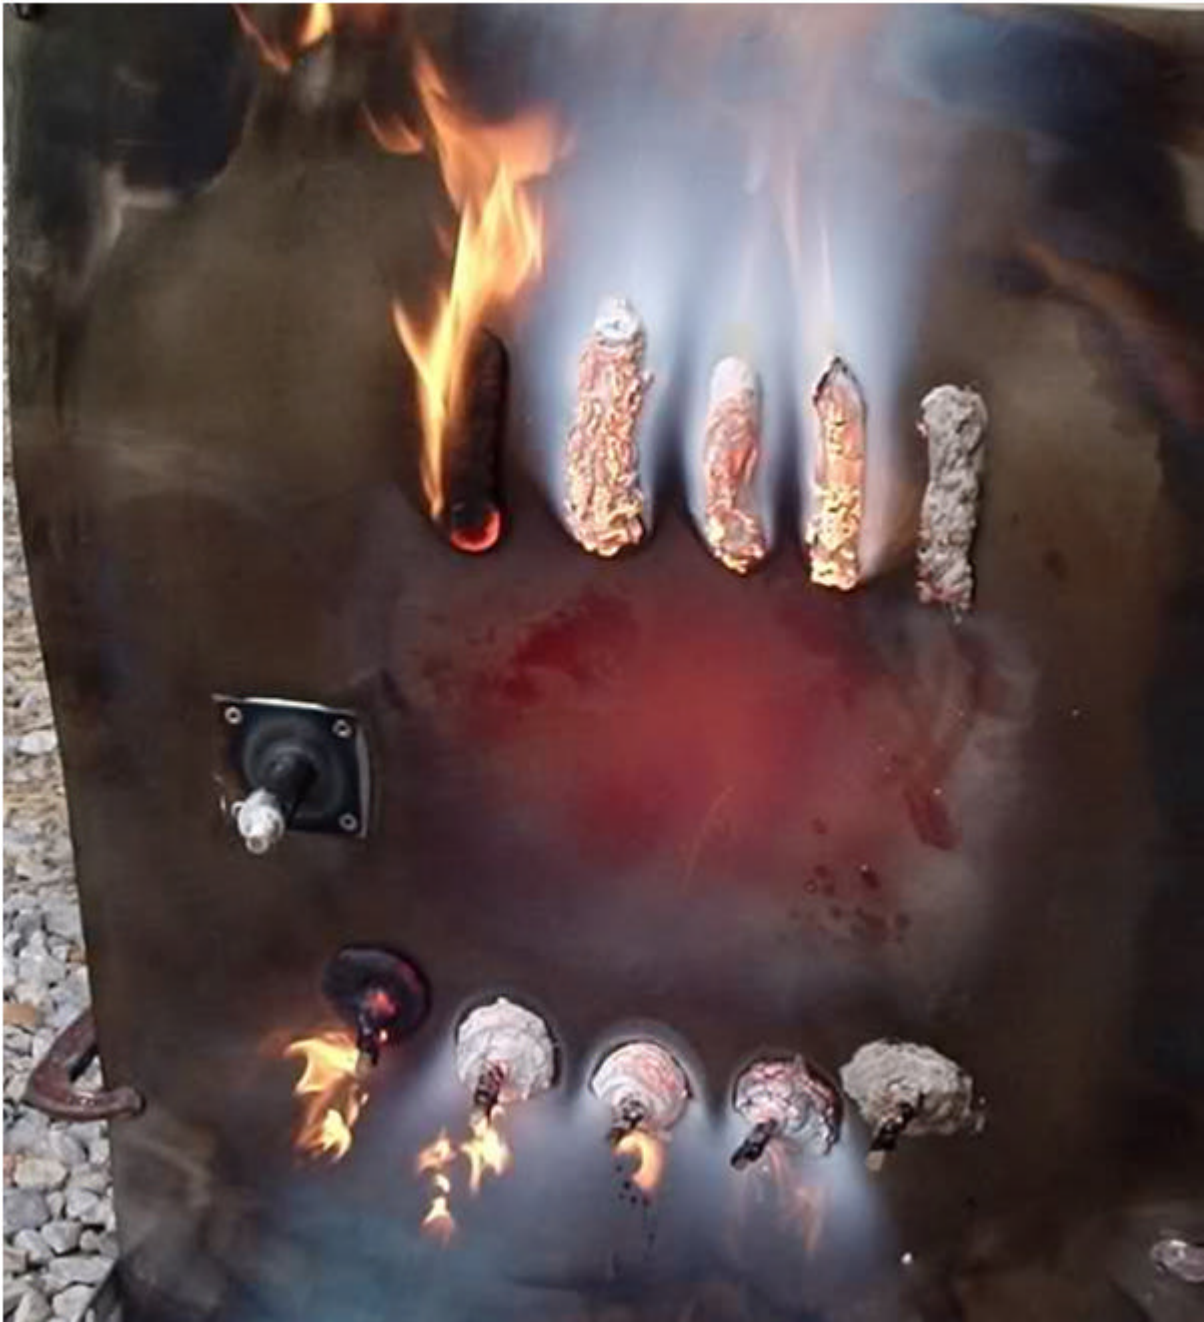
Let's go closer:

Approx 30 seconds into the burn. The CS1900 has burst into flame. All three silicones are also outgassing flammable material, but not like the CS. The Ultra Copper sample is the worst of the silicones in this regard. The burn exhibited by these four samples is not entirely a bad thing, as the probable operating scheme is to form an insulating char. The Resbond appears to be inert. Compare the silicones to the previous setup photo and you'll see the Biotherm and FireBarrier samples are exhibiting some degree of intumescence, swelling and expanding. Now look at the 6-gauge wires; so far all the sealant samples are holding up ok (even if outgassing flammable material), but the wire insulation is burning away. I point this out because sometimes I bump into a builder who assumes Tefzel insulation to be fireproof.....it ain't so.

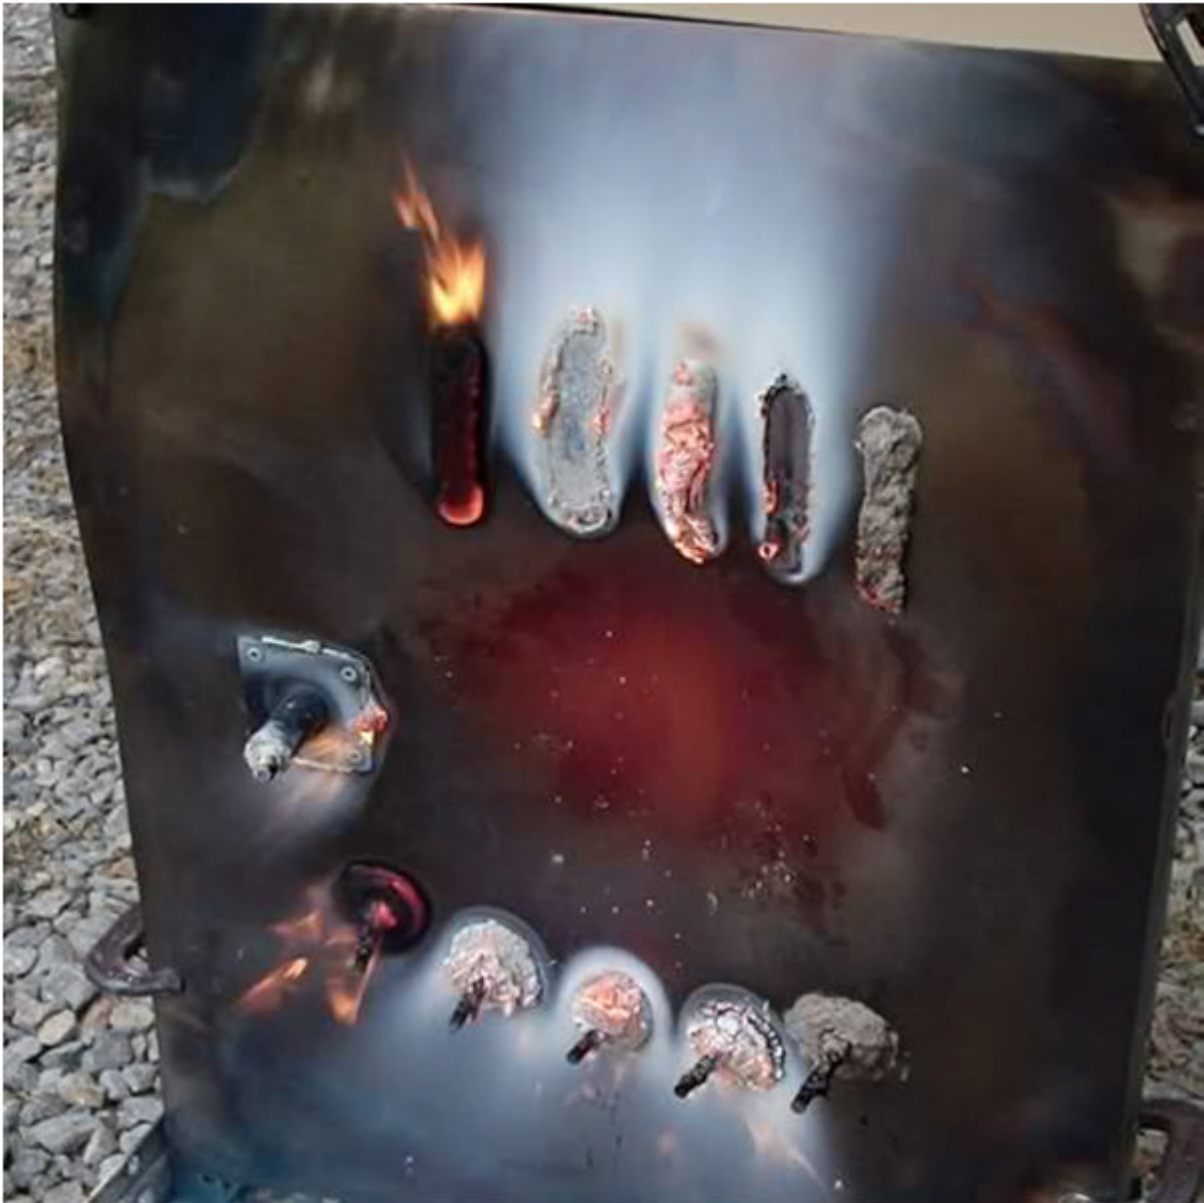
Front of the panel at about 1 minute:

All the pass-through samples have remained intact and formed an insulating char. Of the strip samples, only the CS1900, FireBarrier, and Resbond remain adhered. The difference is mechanical; the 6-gauge wire is keeping the sample in place over each of the bushings. There's a lesson here; give your sealant a mechanical advantage!

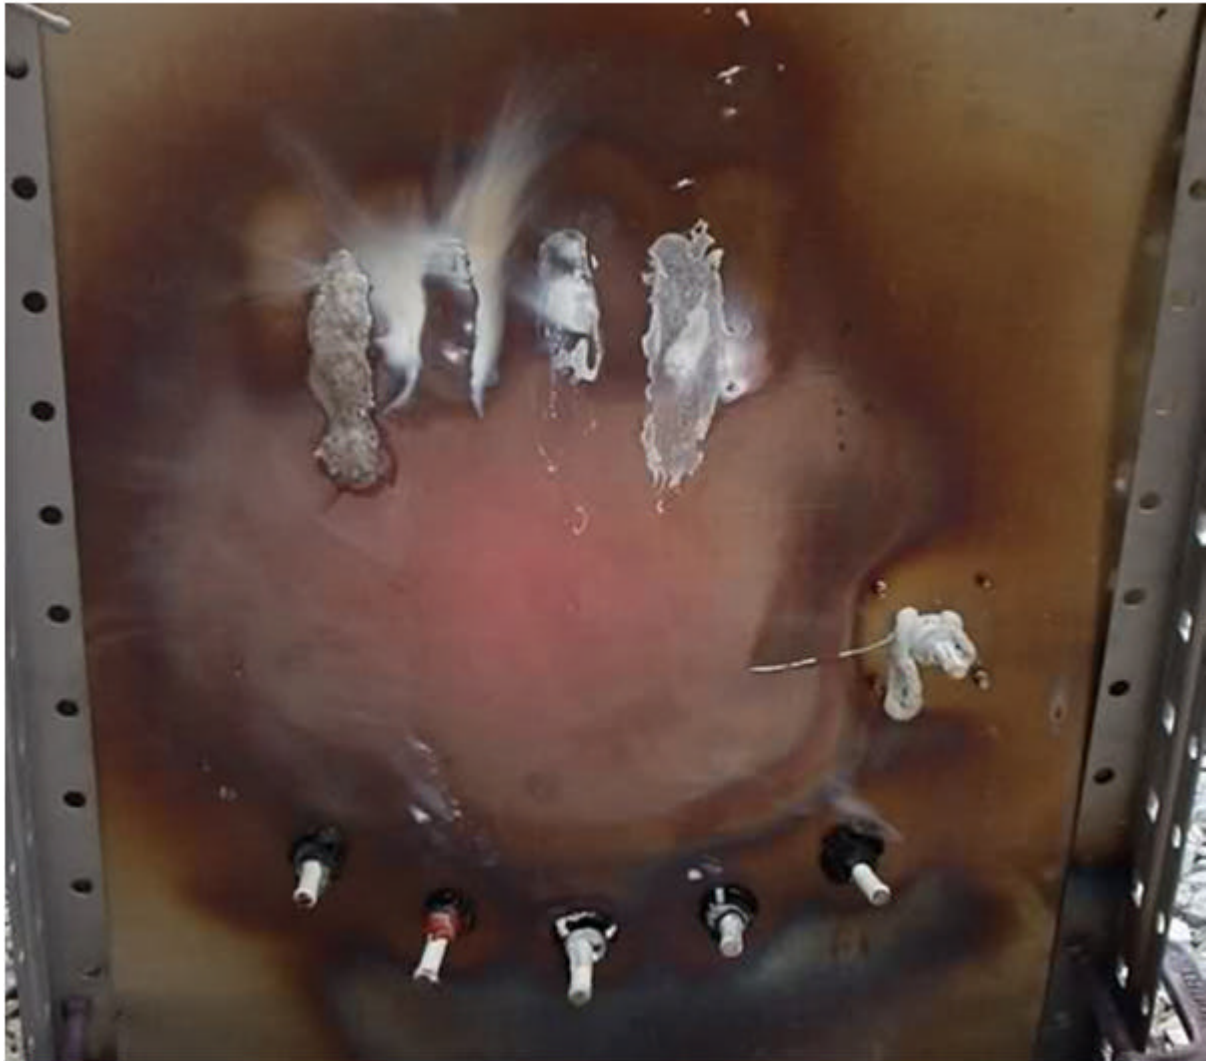
Back of the panel at about 1-1/2 minutes:

The snap bushings are now melting. The copper wire cores are very hot, so the tefzel insulation is beginning to soften and swell. All the strip samples have peeled away, except for the Resbond.

Full failure at less than 2 minutes; the bushings melt, leave a gap, and hot gas is free to do its thing. The CS1900 and Resbond plugs remain pretty much intact and block most of the opening, while the wire stubs collapse the soft silicone chars and fall out of the holes.

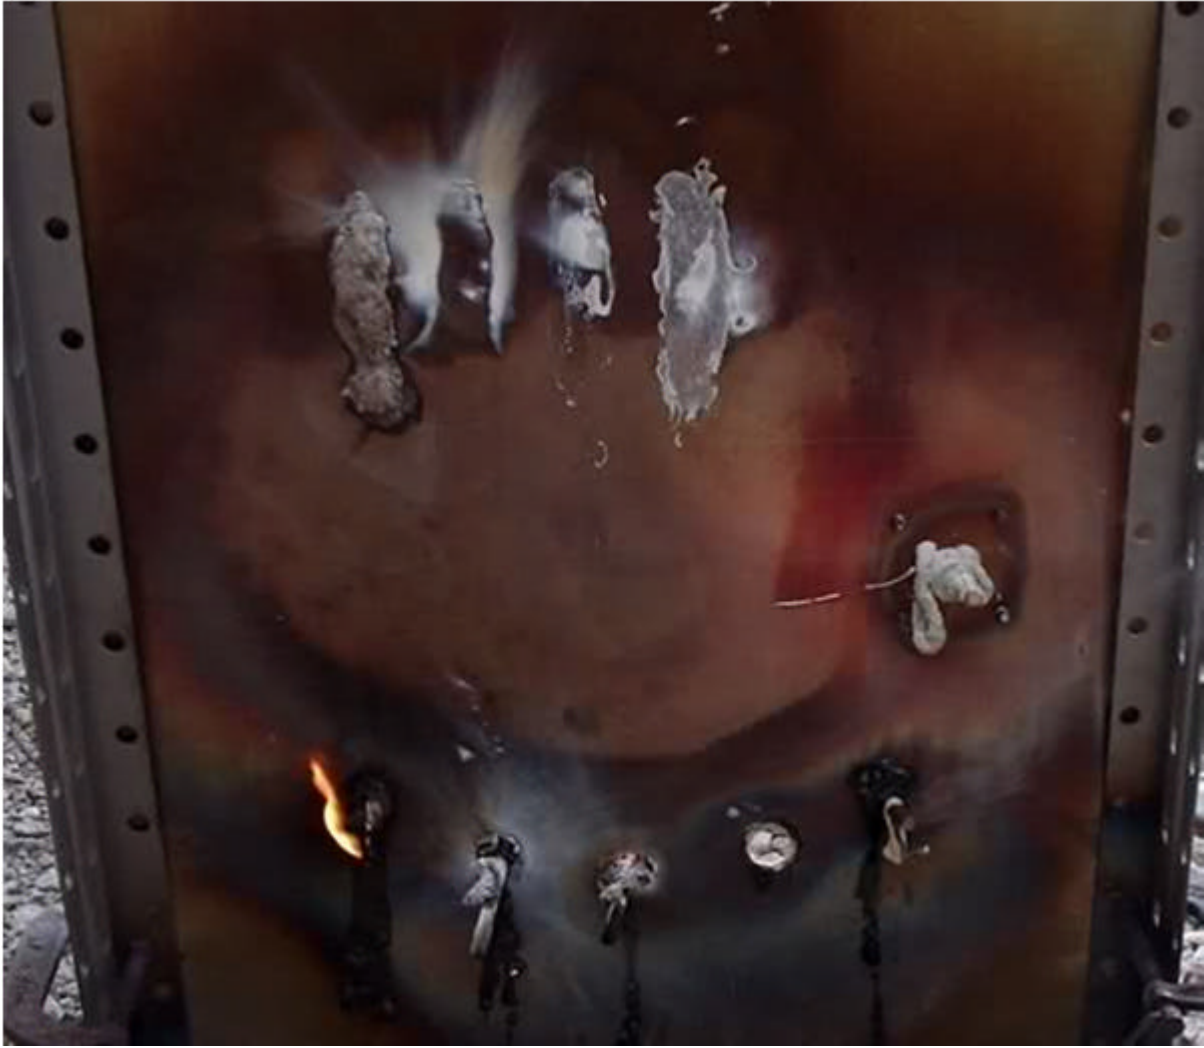
I've moved the torch to aim directly at the welded steel pass through; note the new location of the glowing hot spot. The intumescent FireBarrier is squeezing out everywhere. The fitting remains gas tight despite the heat.

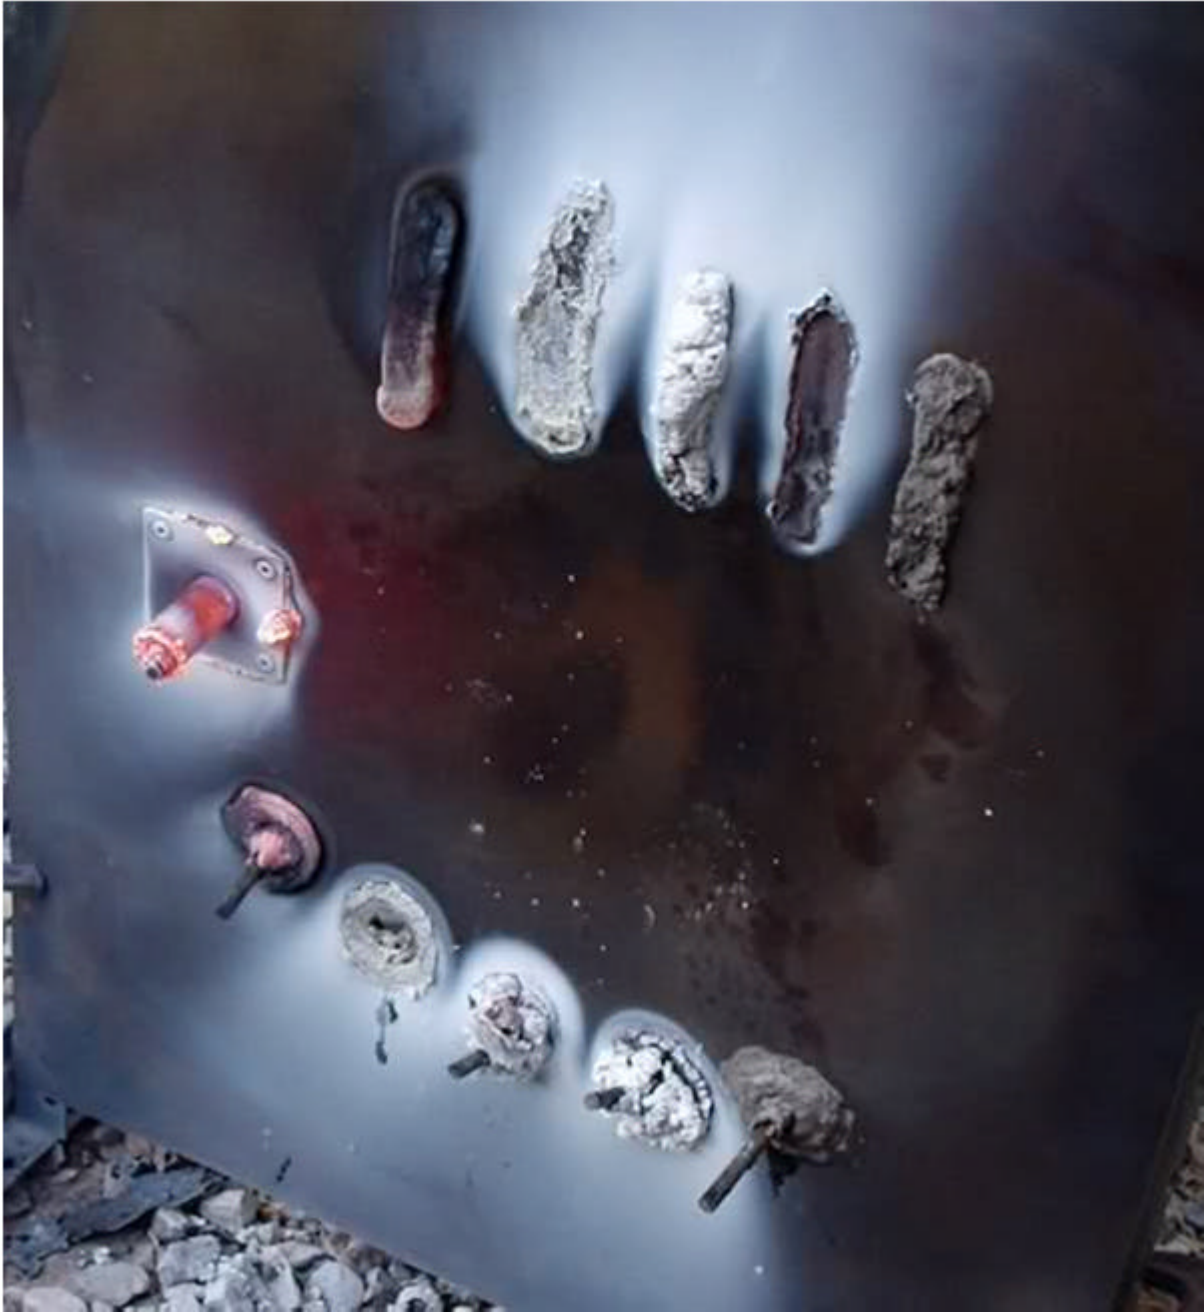
Front side again. The CS1900, FireBarrier, and Resbond strips are still hanging. The torch is aimed directly at the welded tube fitting, which is glowing red. In another minute or two the red hot copper wire core will ignite the tefzel insulation on the opposite side, at which point I ended the burn.

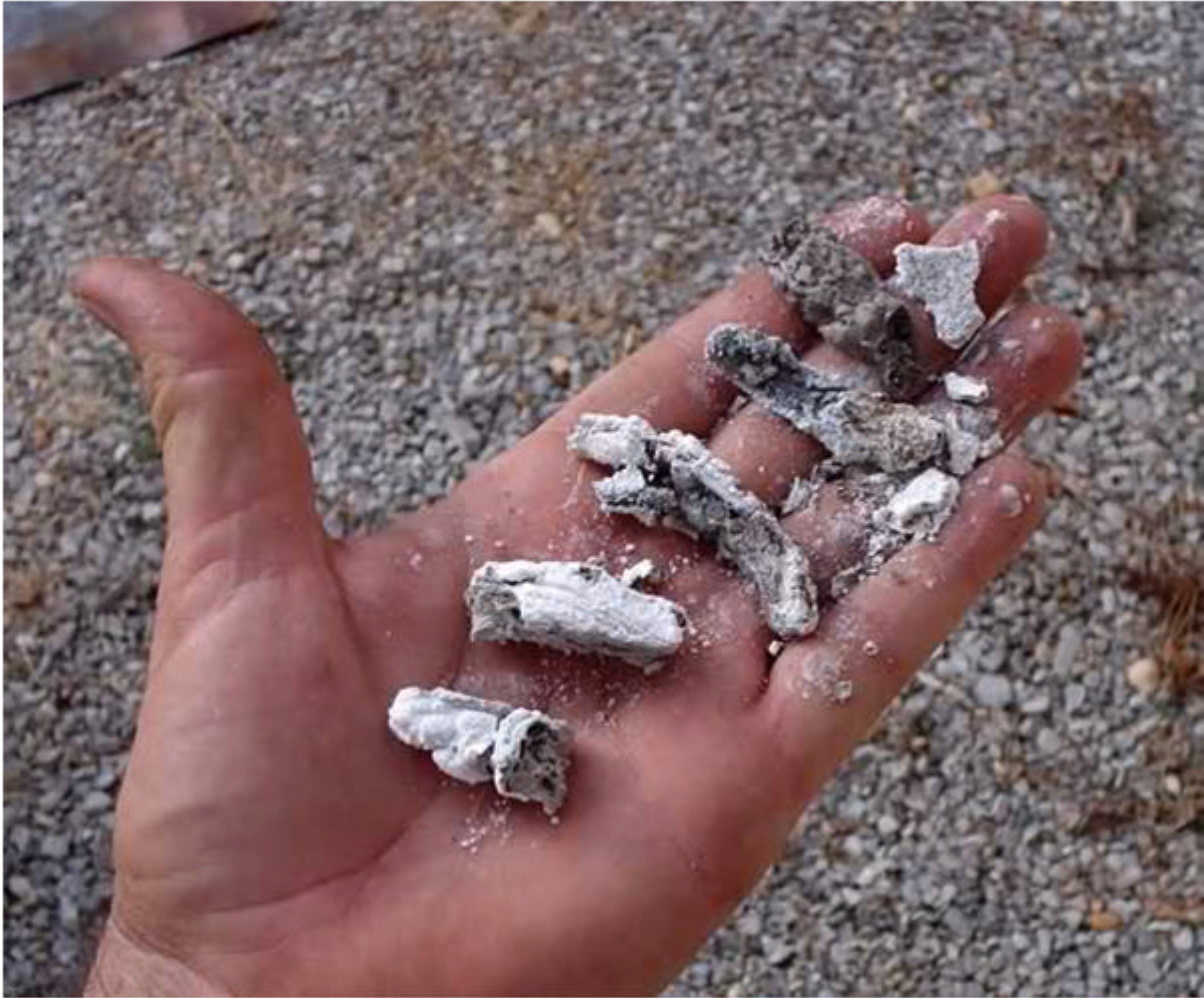
Hot-side chars collected post-burn. They are soft and fragile, puffballs really:

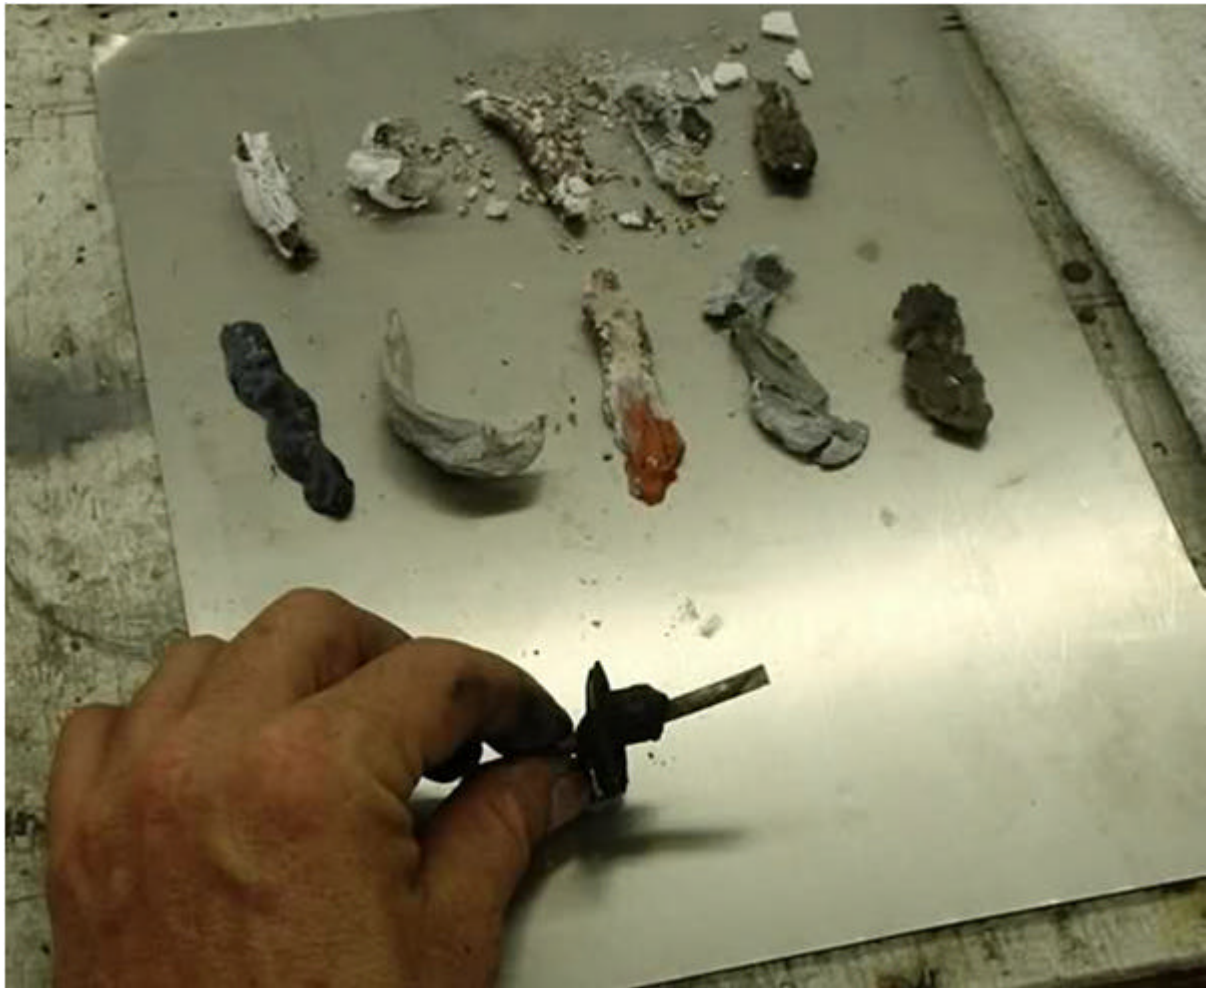
Note the CS1900 char still intact on the wire. It was tougher than the silicone chars. Also note the Resbond strips. Although entirely intact, they released from the stainless with no effort.

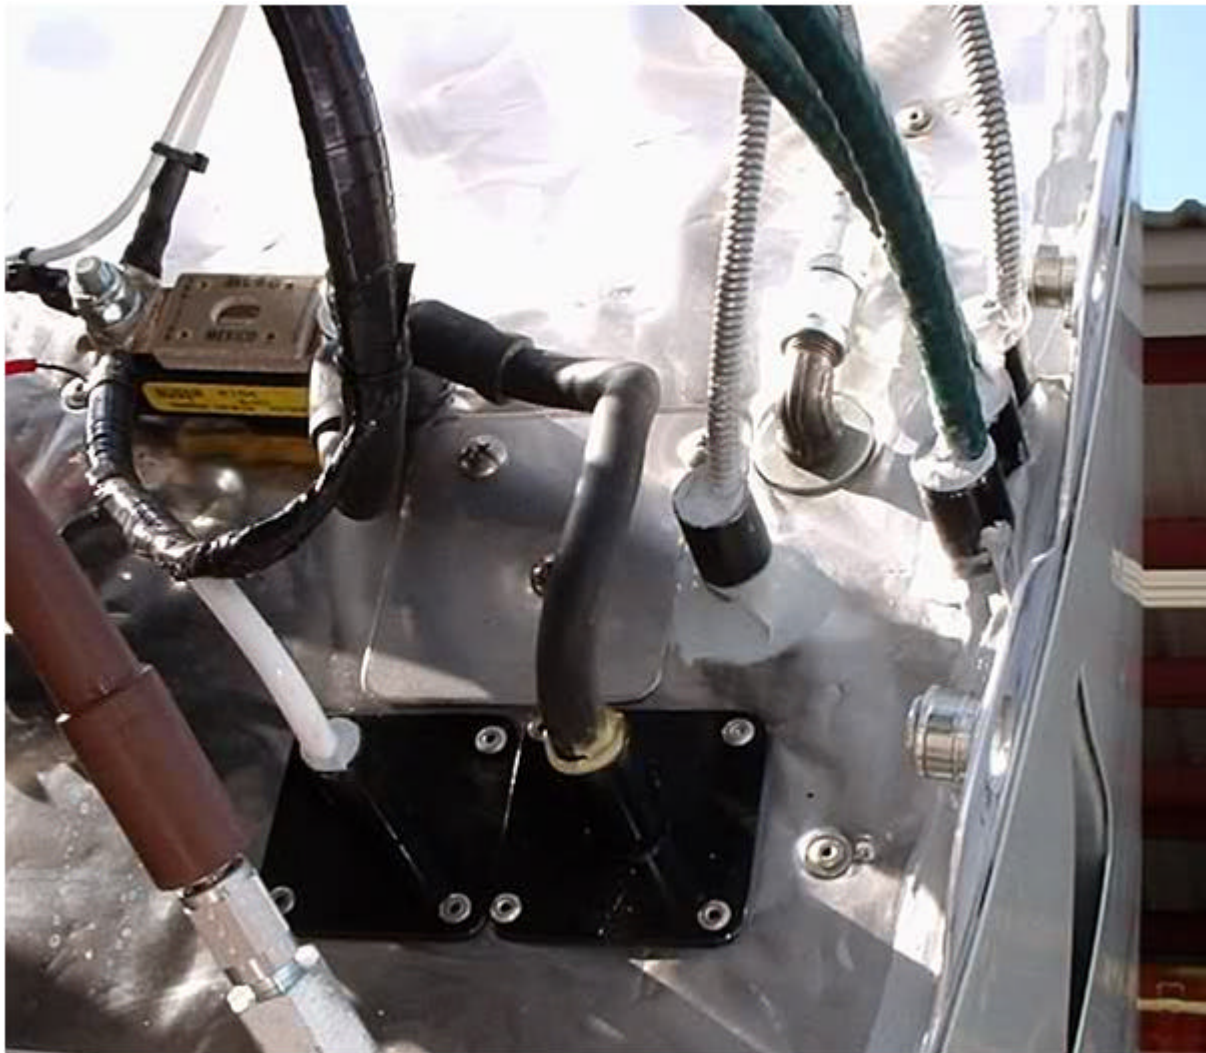
Cables and wires got tubular steel fittings like the one in this test. In the real world FireBarrier is intended for fire sealing cable and pipe passages through walls and ceilings. The surface char insulates the remaining sealant, which is well supported inside the passageway. If the pipe or wire burns away the intumescent property seals the void. No surprise that the same principles work in this airplane adaptation.

The firewall perimeter got a filet of FireBarrier before adding the foil/insulator sandwich, the edges of which were sealed with another filet.

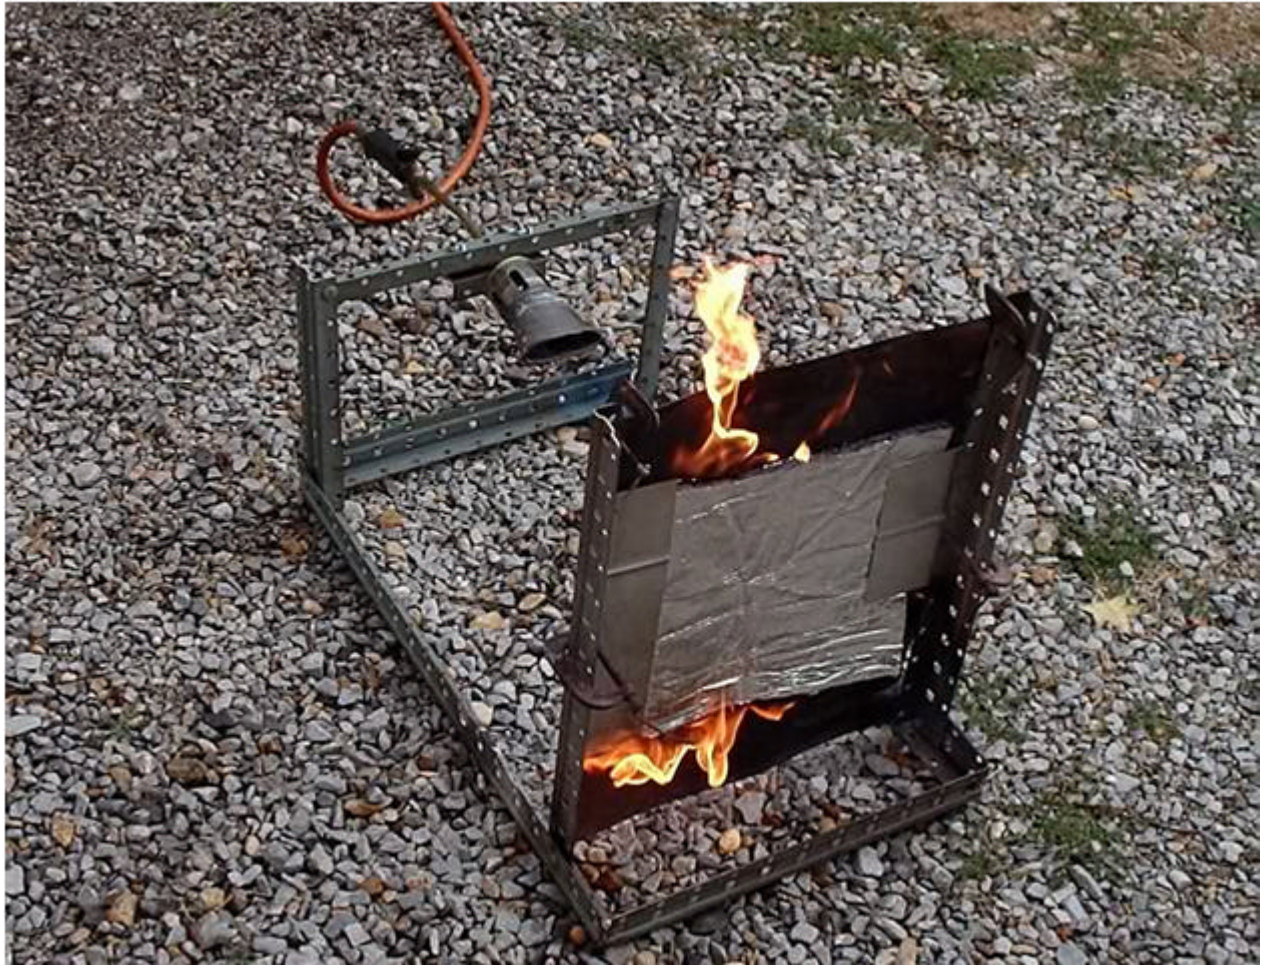
This weekend my buddy Stan and I were standing around the shop enjoying a cool one after doing the sealant burn and I remembered Mike's sample, still in the envelope on the shelf. We walked outside, clamped it to a stainless panel, and hit the burner. This was 15-20 *seconds* later:

Some time ago Mike sent a sample of the insulation installed on the cabin side of his RV-10 firewall. It came to him via a third party rather than a vendor. Mike didn't know for sure what it was, and he had become concerned. Although I could not identify the brand with certainty, I was pretty sure it was a polyester fiber insulation similar to a sample previously tested, and probably the same as that involved in a recent RV-10 incident. I suggested he remove it ASAP.

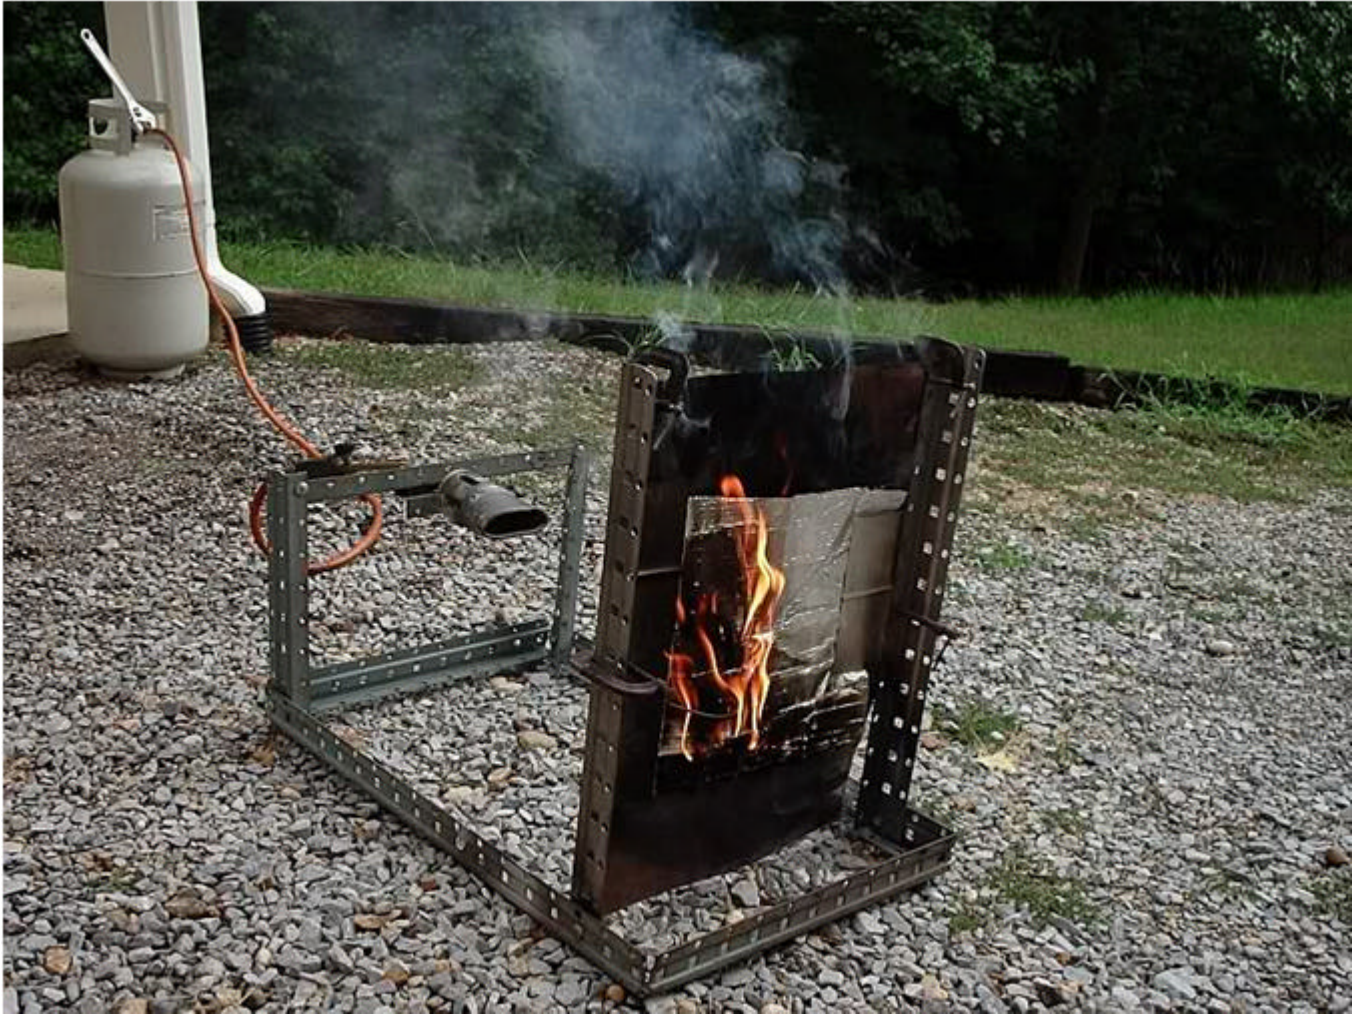
In this photo the burner has been turned off almost a minute. Consider how long that minute might be in the air.
